#### Vehicle Application:

• Toyota Tacoma 5' bed

• 2005 to 2023 Part Number: 1910ì

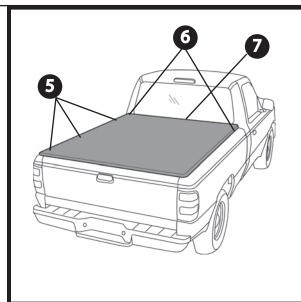
## Place Clamps

Place a Large Outer Clamp Assembly on the Side Rail 6" behind the front pivot mount. Place the a Small Outer Clamp Assembly 6" in front of the rear pivot mount. Locate the center of the Side Rail and place the remaining Large Outer Clamp Assembly either 6" in front of this point or 6" behind it as needed for your vehicle.

Do Not Tighten the Clamps at this time. Repeat on both sides of the vehicle.

Clamp positions may vary depending on any bed accessories you may have.

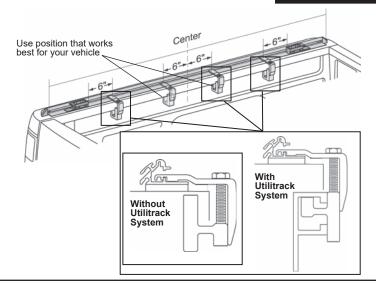
6 Un-do Straps

Un-do the Tie Down Straps.

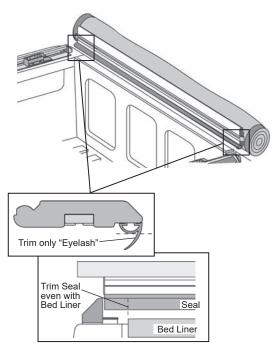
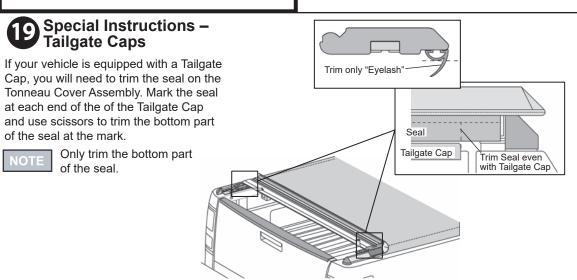
# Special Instructions – Bed Liners

If your vehicle is equipped with a Bed Liner that comes up over the front bulkhead, you will need to trim the seal on the Tonneau Cover Assembly. Mark the seal at each end of the of the Bed Liner and use scissors to trim the bottom, "eyelash", part of the seal at the mark.

Only trim the bottom, "eyelash", part of the seal.
