Vehicle Application:

•: cfX': %) \$ZYI W'\ Yf]HJ[ Y'a cXY'g 6.5' bed 2004-2008 Part Number: 19111

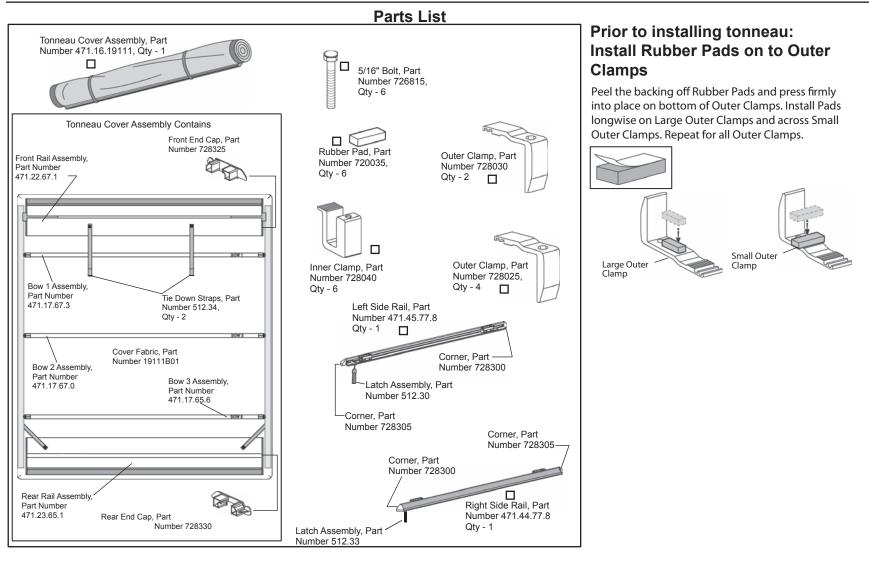
5/16" Bolt

#### Assemble Clamps

Use a 5/16" Bolt to secure an outer clamp to an Inner Clamp. Repeat on all Clamp assemblies
