Assembly Instructions EZ Roll Tonneau

Vehicle Application: Ford F150 Except Heritage Models 5.5' Bed

2004 to 2008 **Part Number:** 19113

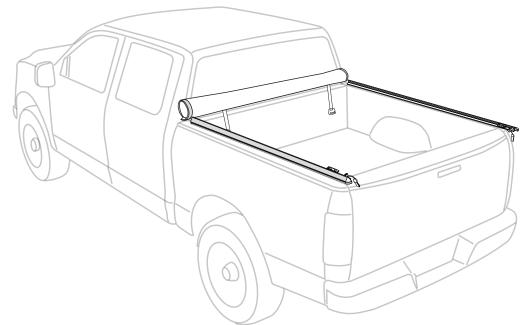
Un-roll the cover and latch the tailgate retainer

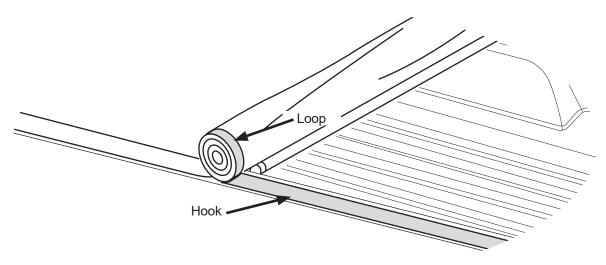
Pull the loop (on the fabric) tight from side to side to the hook (on the rail)

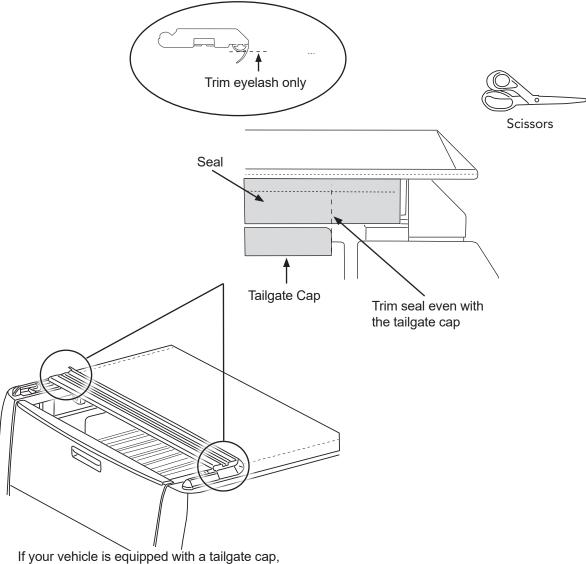
If your vehicle is equipped with a tailgate cap, you will need to trim the seal on the Tonneau Cover Assembly. Mark the seal at each end of the tailgate cap and use the scissors to trim the bottom part of the seal at the mark.

NOTE: Only trim the bottom part of the seal.
