# Assembly Instructions EZ Roll Tonneau

**Vehicle Application:**  
Chevrolet Silverado/GMC Sierra 1500 5.8' Bed  
2007 to 2013  
**Part Number:** 19212

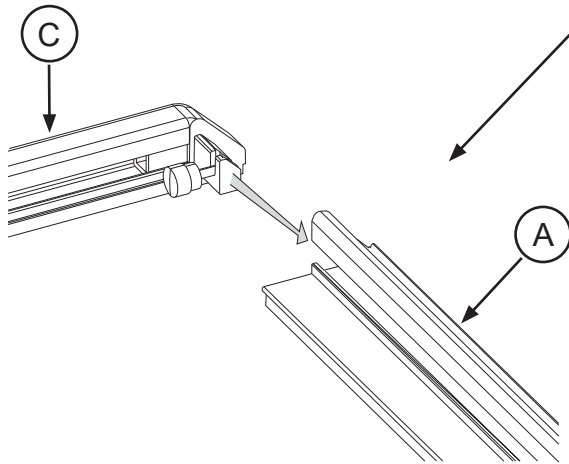
Attach Side Rails to Cover Rail

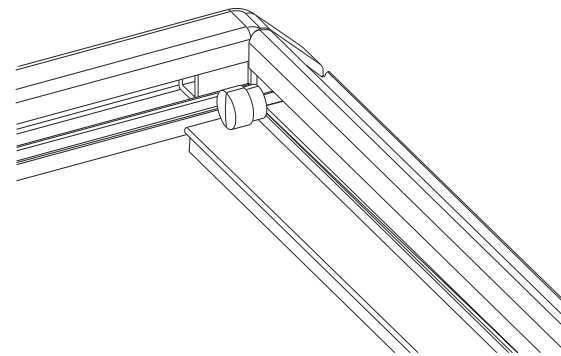
Tighten Thumb Screws

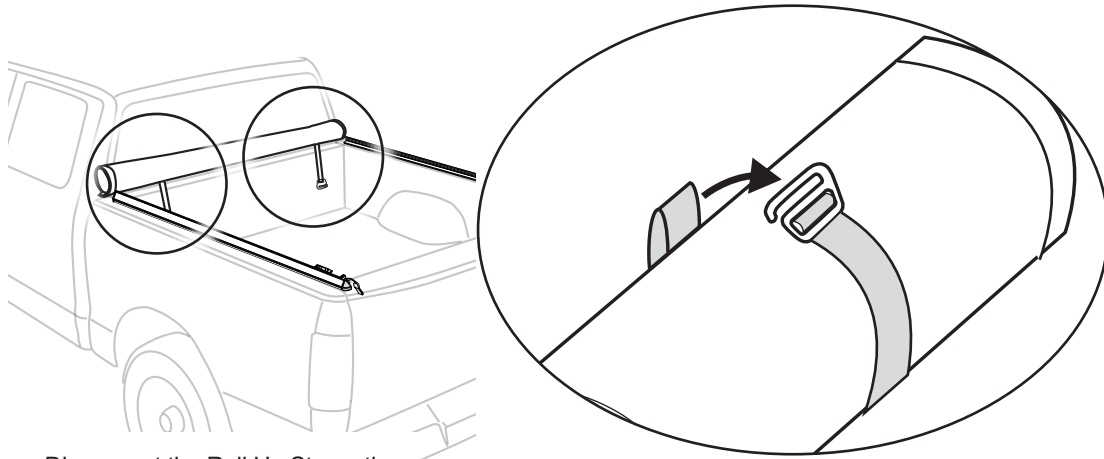
Disconnect the Roll Up Straps then unroll the Tonneau Cover.

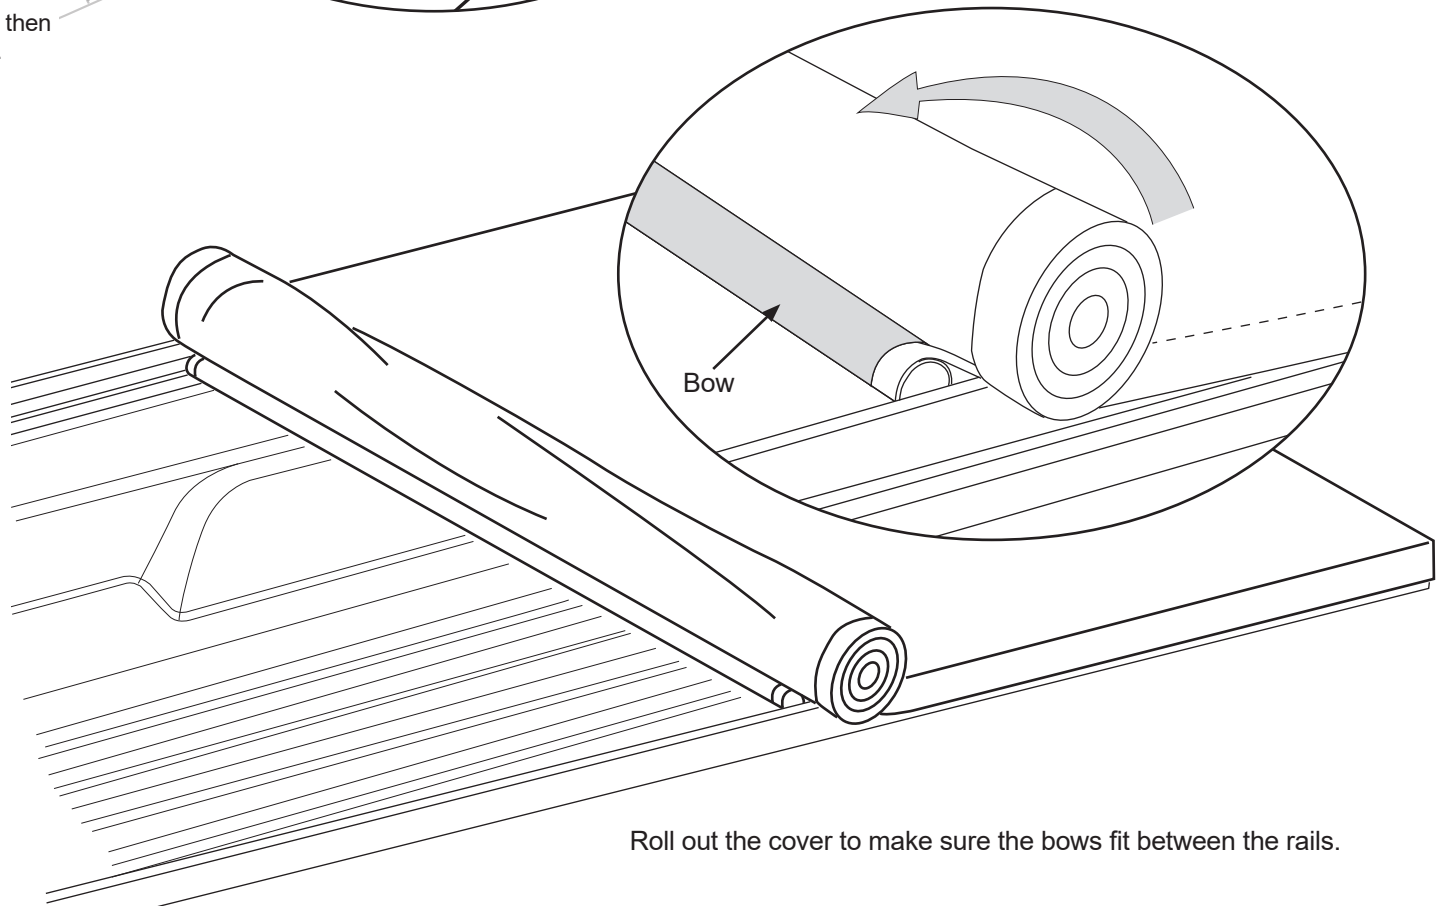
Roll out the cover to make sure the bows fit between the rails.

**NOTE:** Allow a 1/8" gap between the side rails and the rear rail.

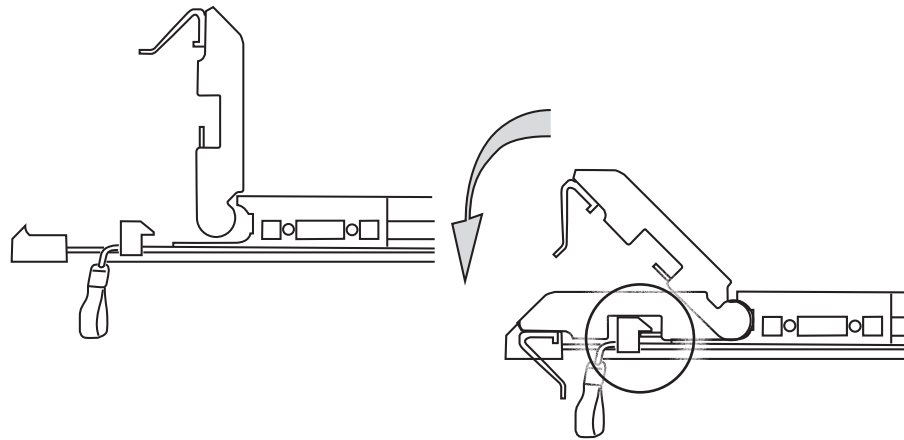
Push down until latch catches.

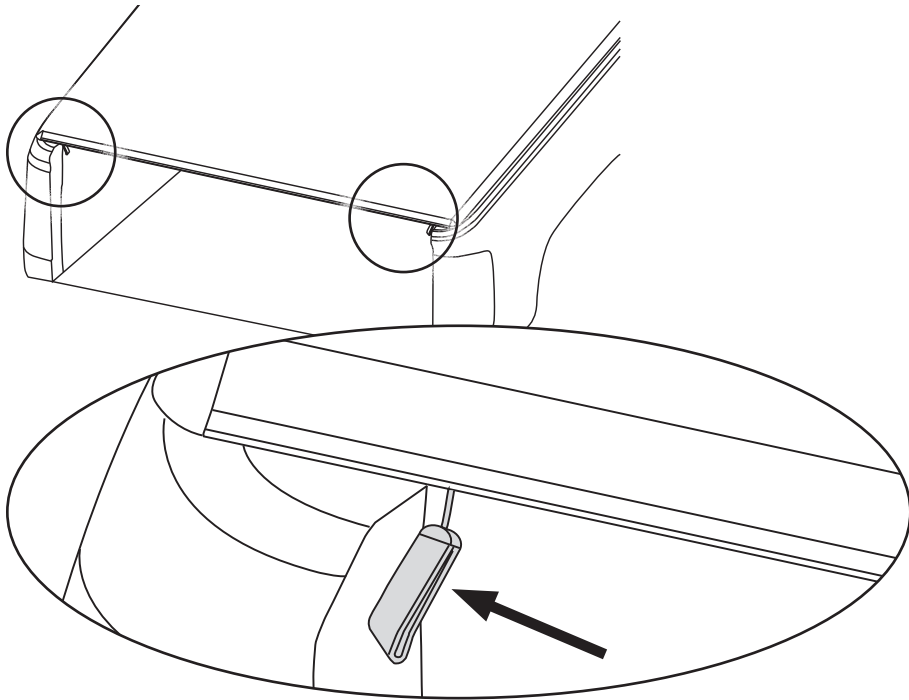
Pull tabs to release rear retainer .

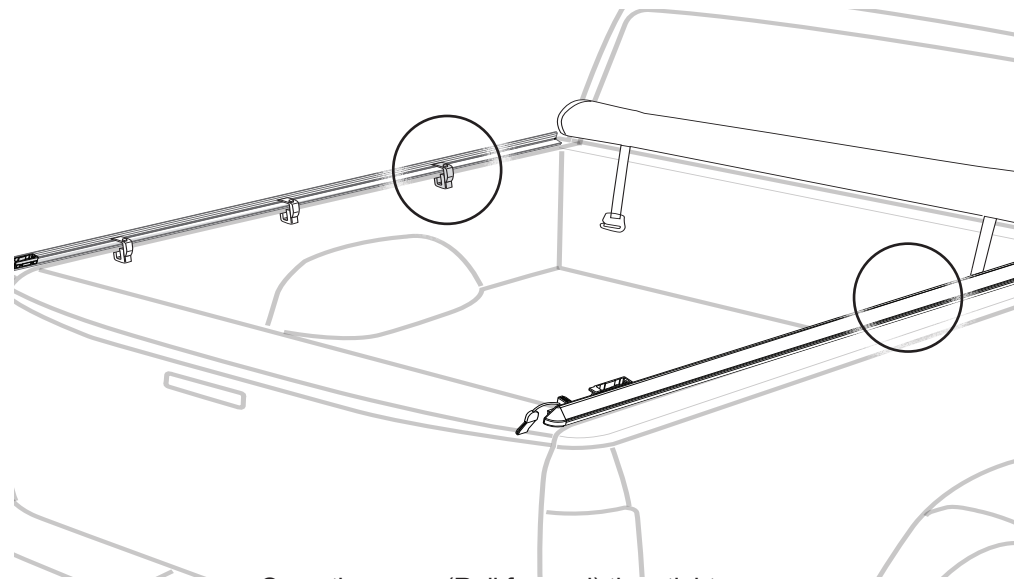
Open the cover (Roll forward) then tighten the front clamps

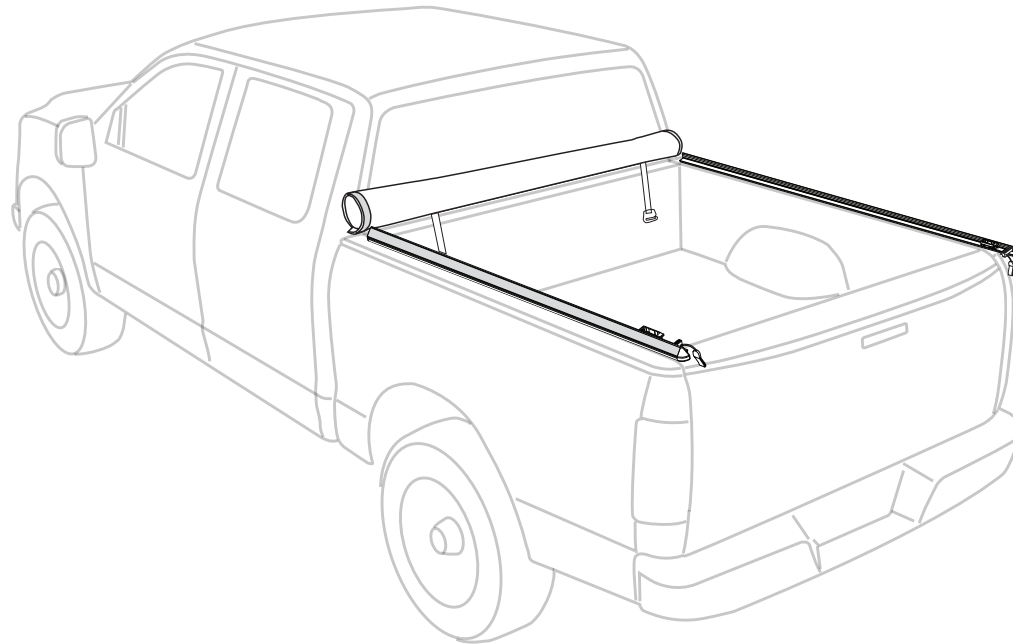
Un-roll the cover and latch the tailgate retainer
