Vehicle Application:

Chevrolet Colorado/Canyon 6.2' bed • 2015 - 2022 Part Number: 19220

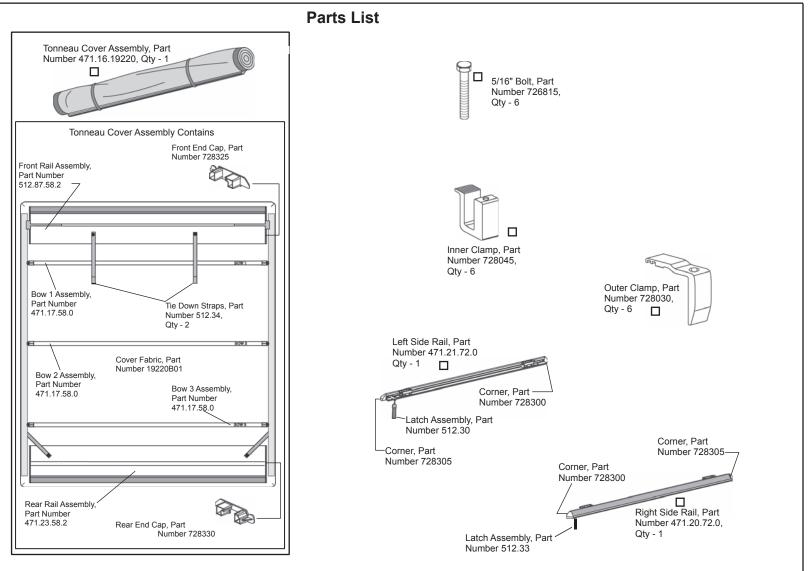
5/16" Bolt

Use a 5/16" Bolt to secure an Outer Clamp to an Inner Clamp. Repeat for six (6) assemblies.
