#### Vehicle Application:

- Ford F250/350
- 6.8 bed, 2017-Current
- Part Number: 19222

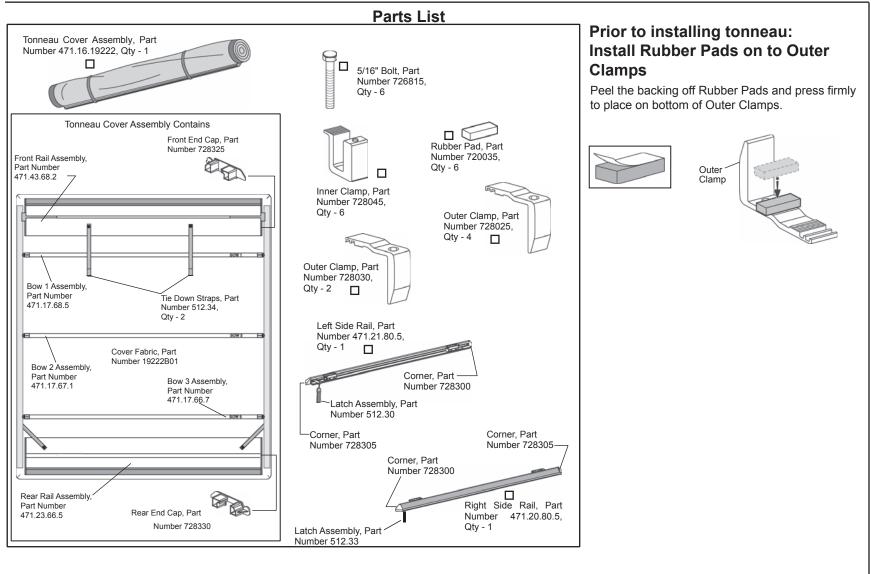
5/16" Bolt

Use a 5/16" Bolt to secure an Outer Clamp to an Inner Clamp. Repeat for six (6) assemblies.
