#### Vehicle Application:

- Chevrolet Gi YfUXc/GMC GIYffU 6.5' bed 2019-Current (new body style)
- Part Number: 19225

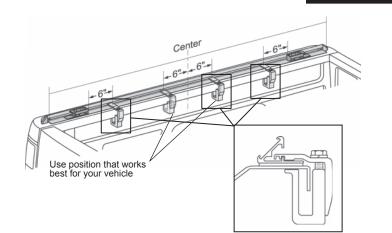
**6** Un-do Straps Un-do the Tie Down Straps.

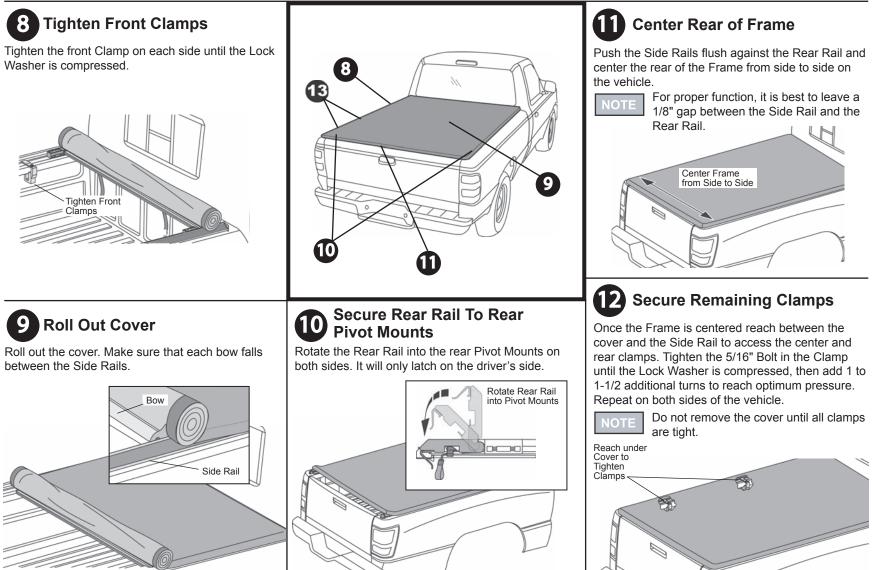
### 7 Center Tonneau Frame

With the Tonneau Cover Assembly latched on both sides, push both Side Rails in so they are flush with the Front Rail. Center the front of the Frame from side to side on the vehicle.

For proper function, it is best to leave a 1/8" gap between the Side Rail and the Front Rail.
