Vehicle Application:

- RAM 1500 6.5' BED
- 2019-Current
- Part Number: 19228

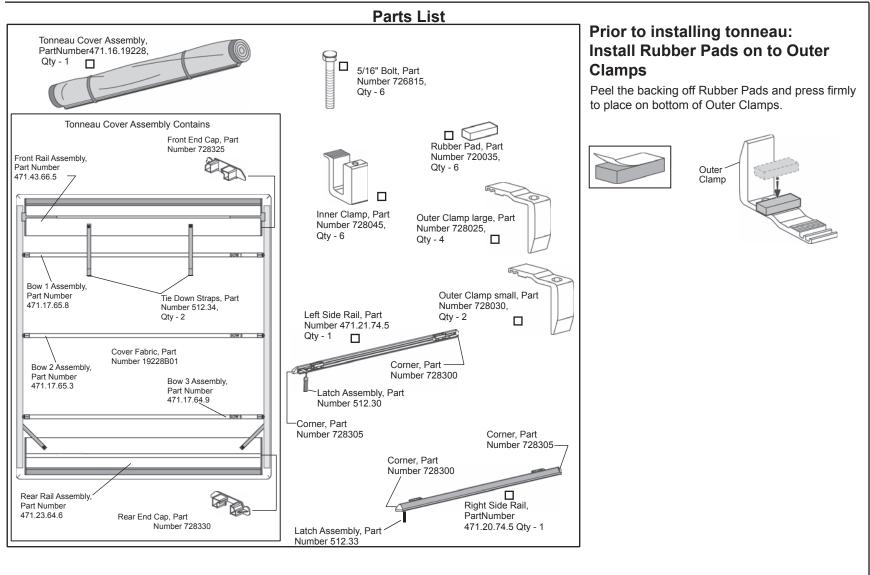
-5/16" Bolt

#### Assemble Clamps

Use a 5/16" Bolt to secure an outer clamp to an Inner Clamp. Repeat on all Clamp assemblies.

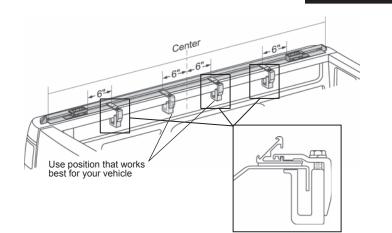
**6** Un-do Straps Un-do the Tie Down Straps.
