Assembly Instructions EZ Roll Tonneau

Vehicle Application:
Toyota Tacoma 6' Bed
2024 to Current
Part Number: 19248

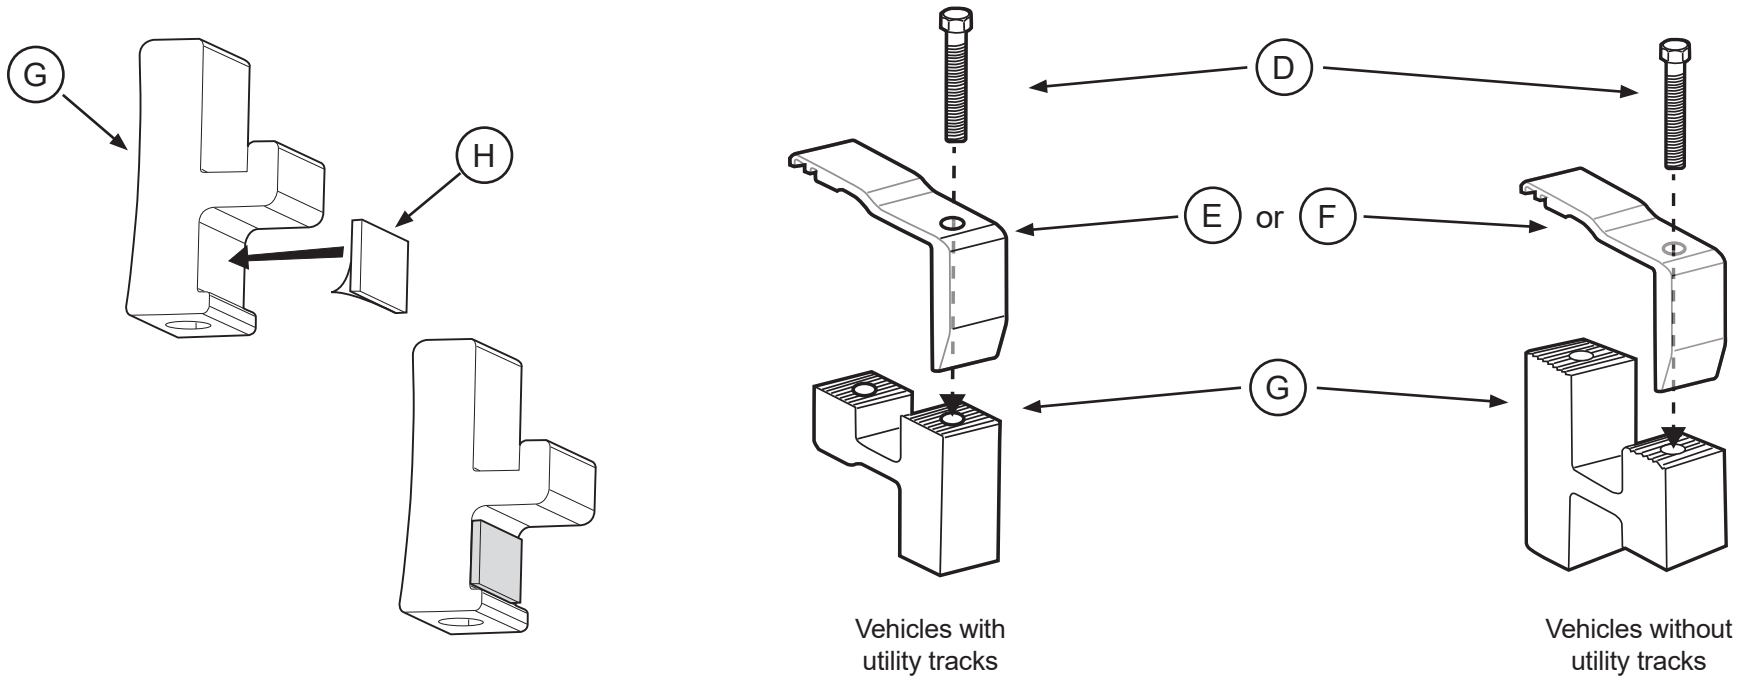
Remove paper backing from foam tape
