# Assembly Instructions EZ Roll Tonneau

Vehicle Application:  
Toyota Tacoma 5' Bed  
2024 to Current  
Part Number: 19249

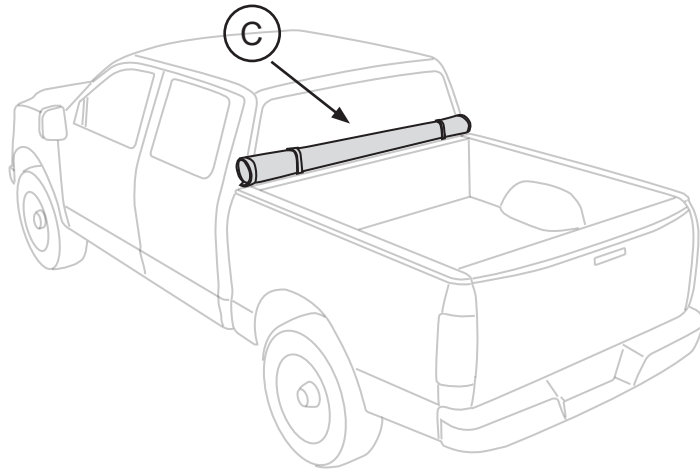
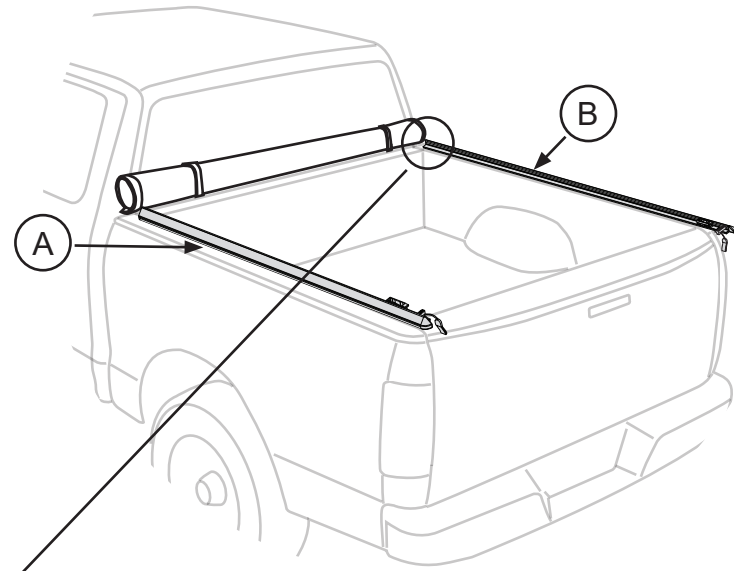
Fabric not shown for illustration purpose

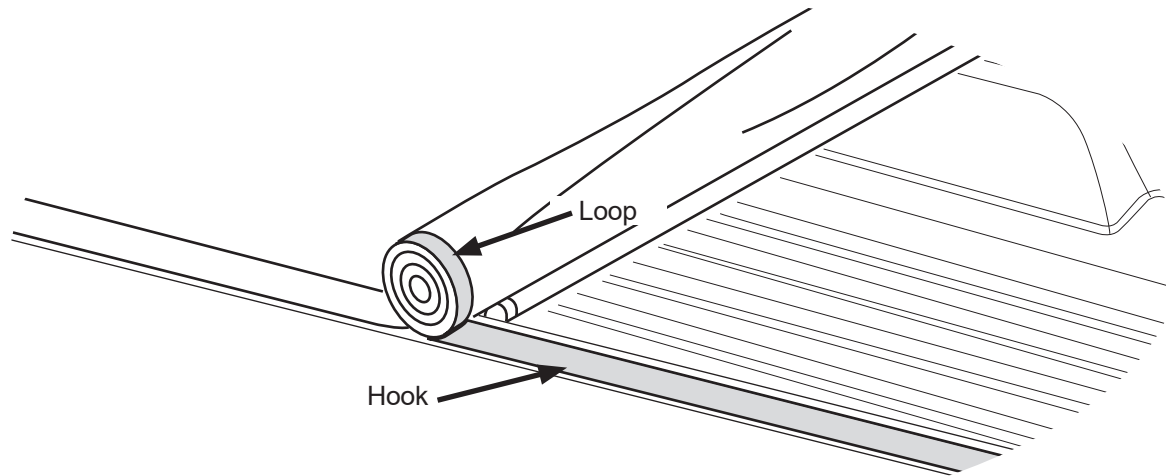
Pull the loop (on the fabric) tight from side to side to the hook (on the rail)

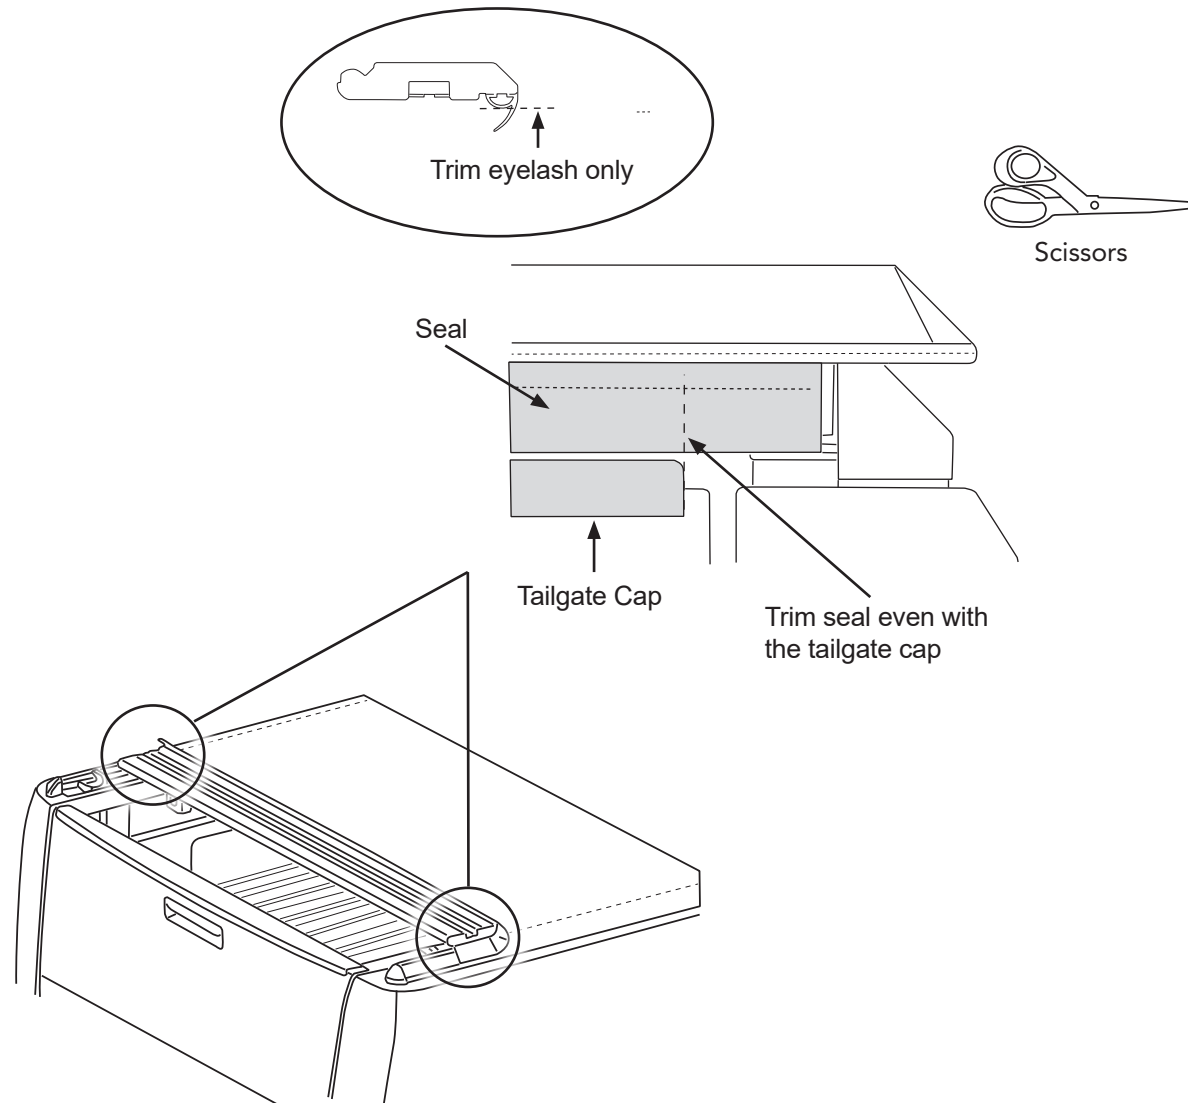
If your vehicle is equipped with a tailgate cap, you will need to trim the seal on the Tonneau Cover Assembly. Mark the seal at each end of the tailgate cap and use the scissors to trim the bottom part of the seal at the mark.

**NOTE:** Only trim the bottom part of the seal.
