•Dodge RAM 2002-2008 1500 6.5' Bed Part Number: 16238

#### **EZ-Fold Tonneau Installation Instructions**

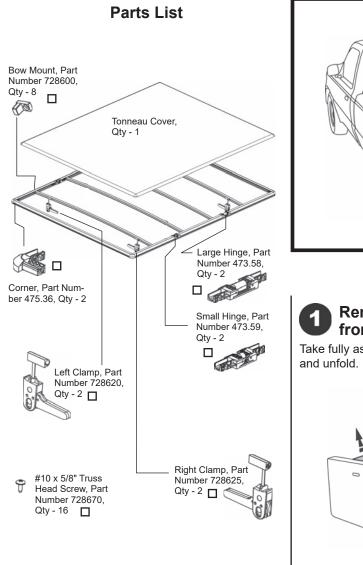
#### **Remove EZ-Fold Tonneau** from Box

Take fully assembled EZ-Fold Tonneau out of box

#### **Place Tonneau on Bed** 2

Place the Tonneau on the vehicle with the retaining straps facing up. Align the outside edge of the front rail with the outside edge of the bed. Center the Tonneau from side to side.

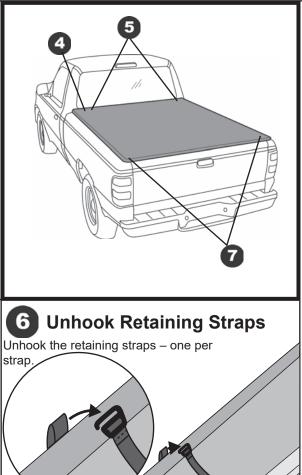
# 5 Secure Front Clamp

Pull the handle up to secure the clamp.

Repeat Steps 3 - 5 on the passenger side.

Make sure clamps are secure before operating vehicle.

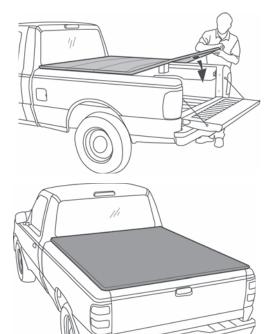
# Secure Tonneau

Lower the tailgate and unfold the Tonneau to cover the bed.

Repeat Steps 3 - 5 to secure the rear clamps on both sides of the vehicle.
