### **Vehicle Application:**

Nissan Frontier

6' bed 05-Current

Part Number: 19147

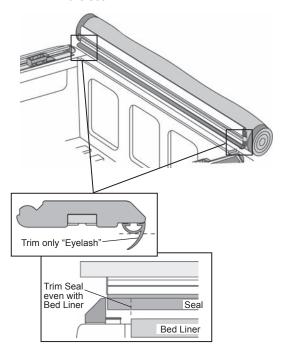
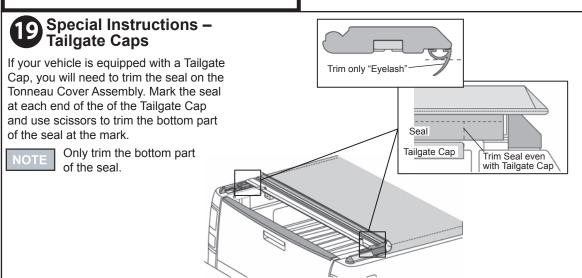
# Special Instructions – Bed Liners

If your vehicle is equipped with a Bed Liner that comes up over the front bulkhead, you will need to trim the seal on the Tonneau Cover Assembly. Mark the seal at each end of the of the Bed Liner and use scissors to trim the bottom, "eyelash", part of the seal at the mark.

Only trim the bottom, "eyelash", part of the seal.
