#### **Vehicle Application:**

Chevrolet Colorado/GMC Canyon

5' bed 04-2012

Part Number: 19151

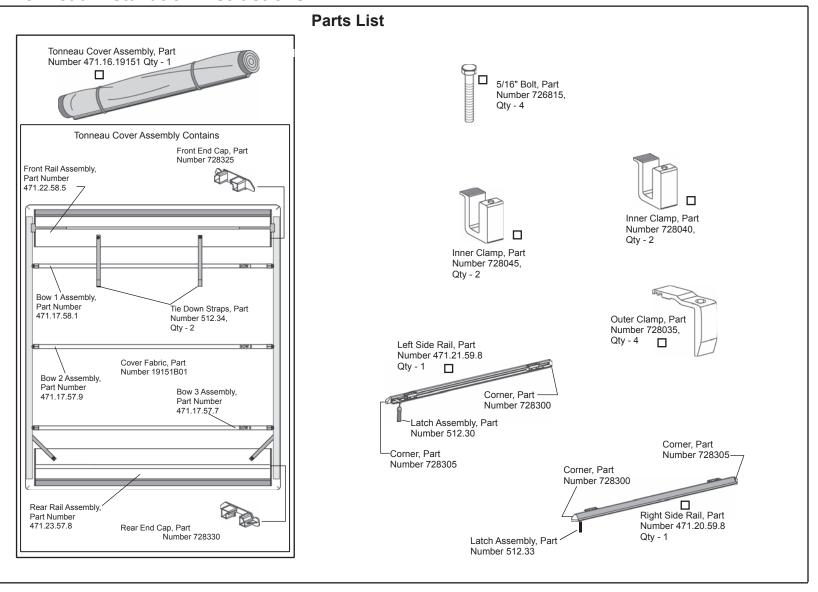
If the vehicle has an Over-the-Rail Bedliner, use a certified installer to perform the initial installation. Modifications to the Bedliner may be required.

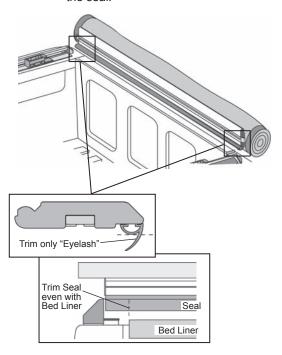
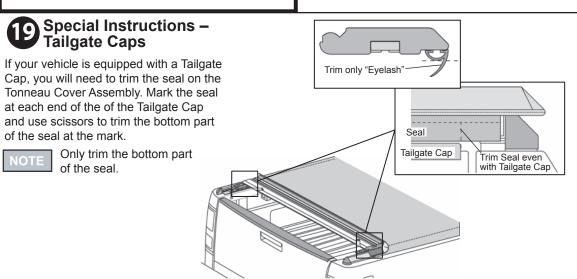
# Special Instructions – Bed Liners

If your vehicle is equipped with a Bed Liner that comes up over the front bulkhead, you will need to trim the seal on the Tonneau Cover Assembly. Mark the seal at each end of the of the Bed Liner and use scissors to trim the bottom, "eyelash", part of the seal at the mark.

Only trim the bottom, "eyelash", part of the seal.
