Chevrolet Silverado / Sierra

5.8' Bed

07- 13 1500 & 2014 HD Part Number: 19212

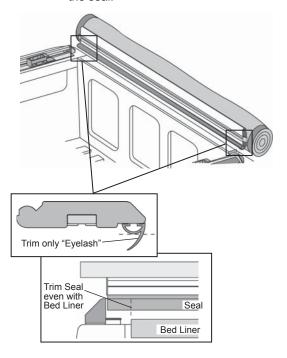
Special Instructions – **Bed Liners**

If your vehicle is equipped with a Bed Liner that comes up over the front bulkhead, you will need to trim the seal on the Tonneau Cover Assembly. Mark the seal at each end of the of the Bed Liner and use scissors to trim the bottom, "eyelash", part of the seal at the mark.

Only trim the bottom, "eyelash", part of the seal.
