Assembly Instructions EZ Roll Tonneau

Vehicle Application:
Chevrolet Colorado/GMC Canyon 6.2' Bed
2015 to 2023
Part Number: 19220

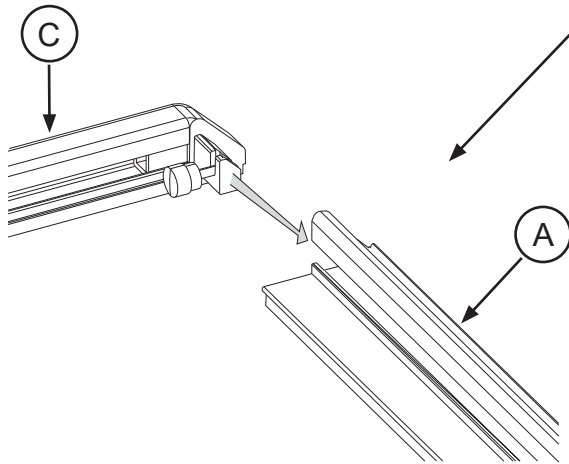
Attach Side Rails to Cover Rail

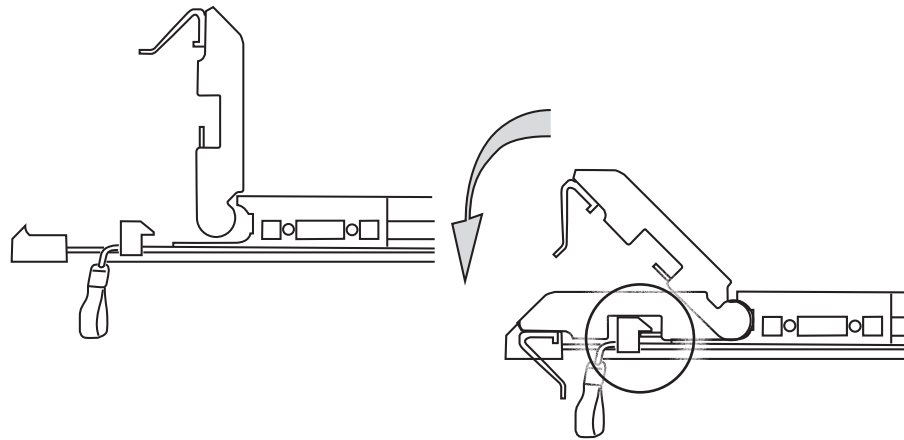
Push down until latch catches.
