Assembly Instructions EZ Roll Tonneau

Vehicle Application:
RAM 5.7' Bed
2019 to Current
Part Number: 19227

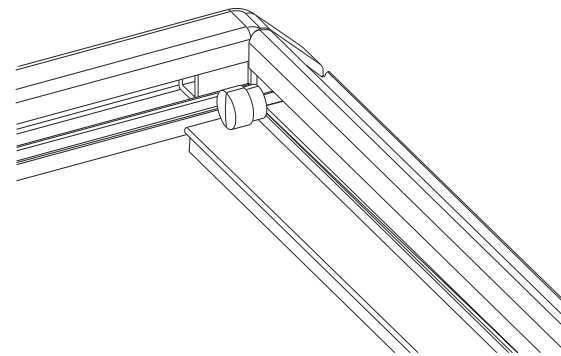
Tighten Thumb Screws

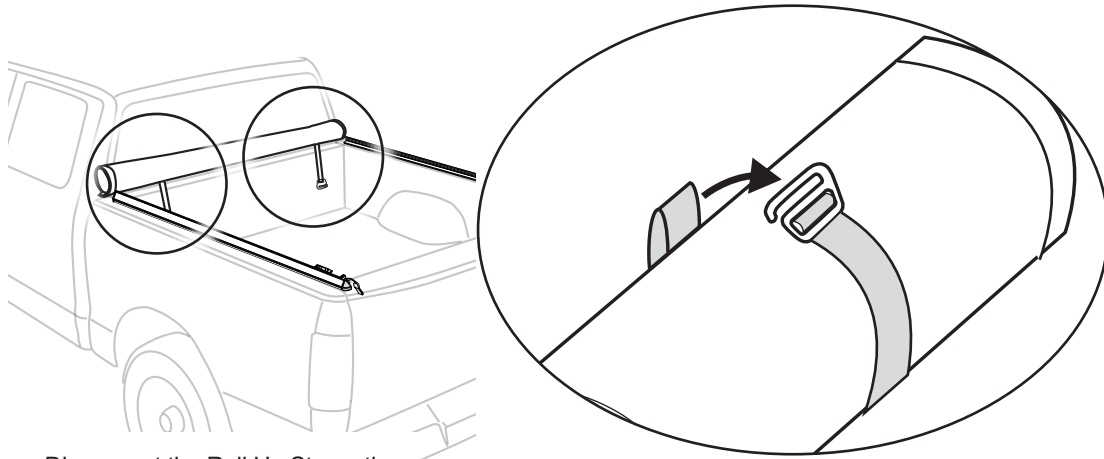
Disconnect the Roll Up Straps then unroll the Tonneau Cover.

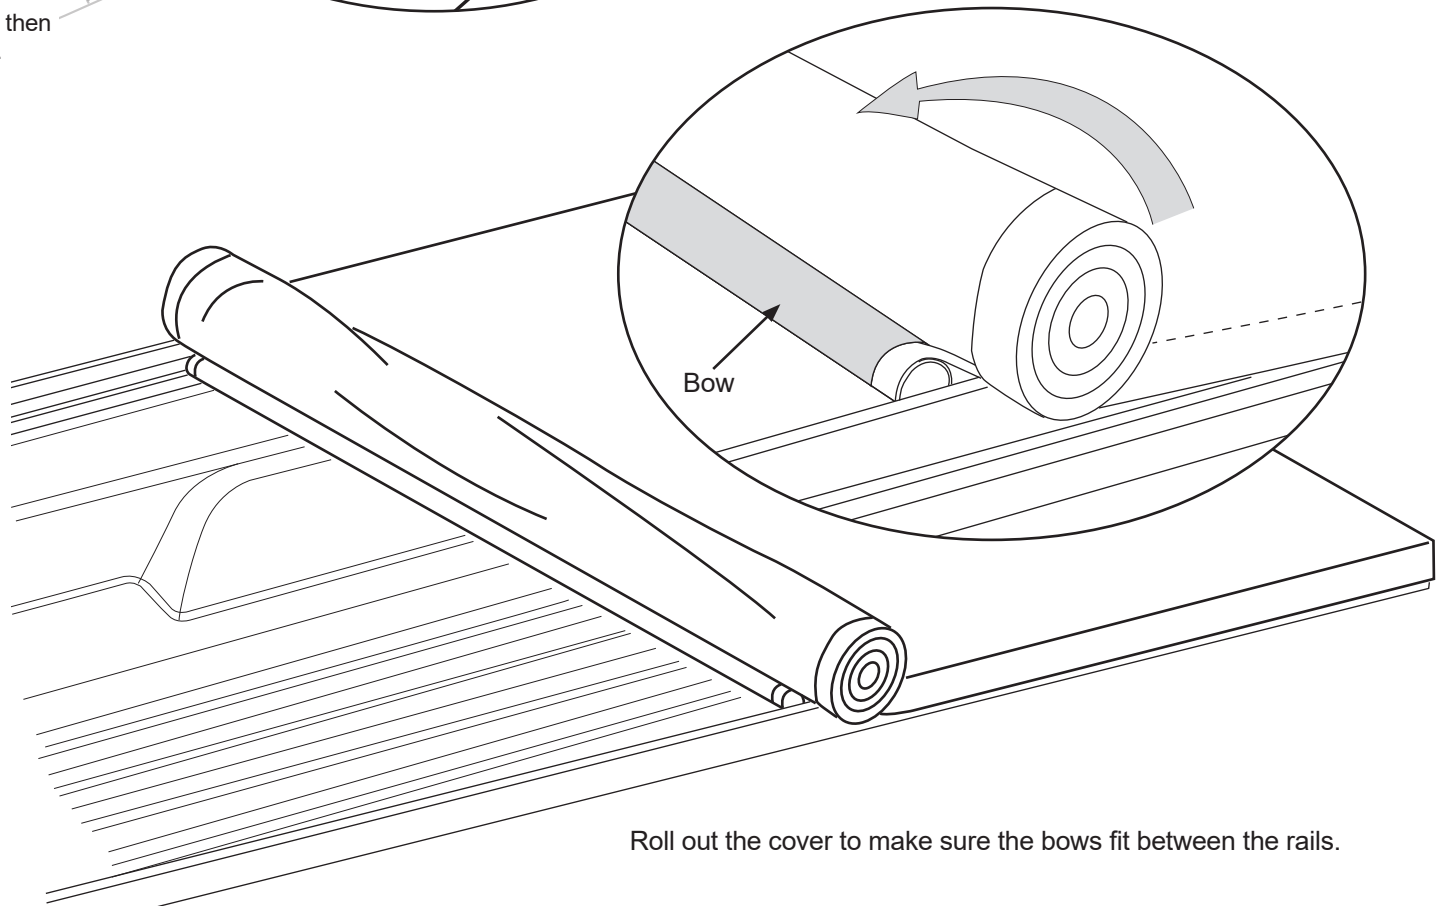
Roll out the cover to make sure the bows fit between the rails.

NOTE: Allow a 1/8" gap between the side rails and the rear rail.

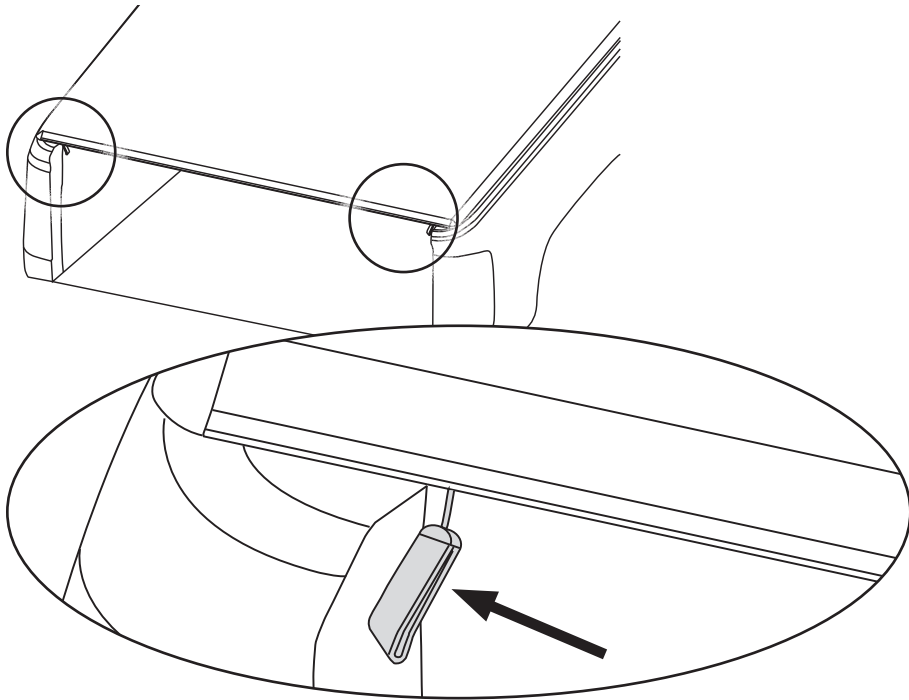
Pull tabs to release rear retainer .

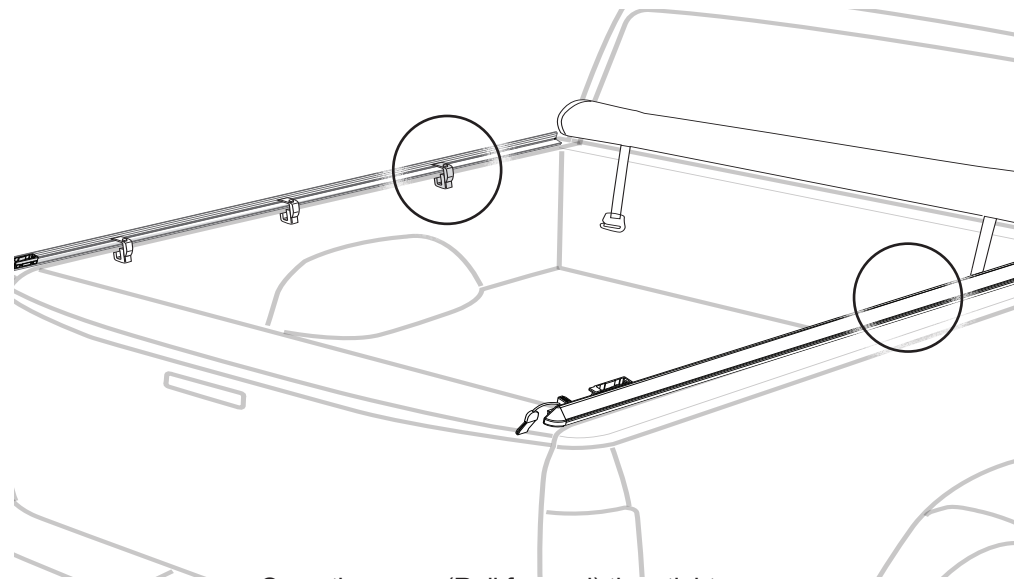
Open the cover (Roll forward) then tighten the front clamps

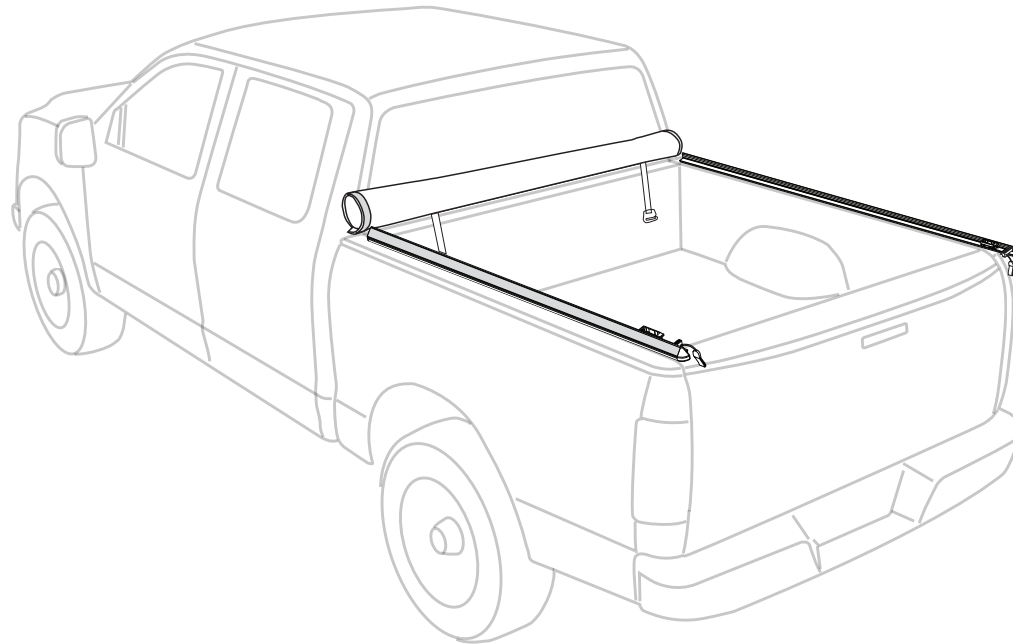
Un-roll the cover and latch the tailgate retainer

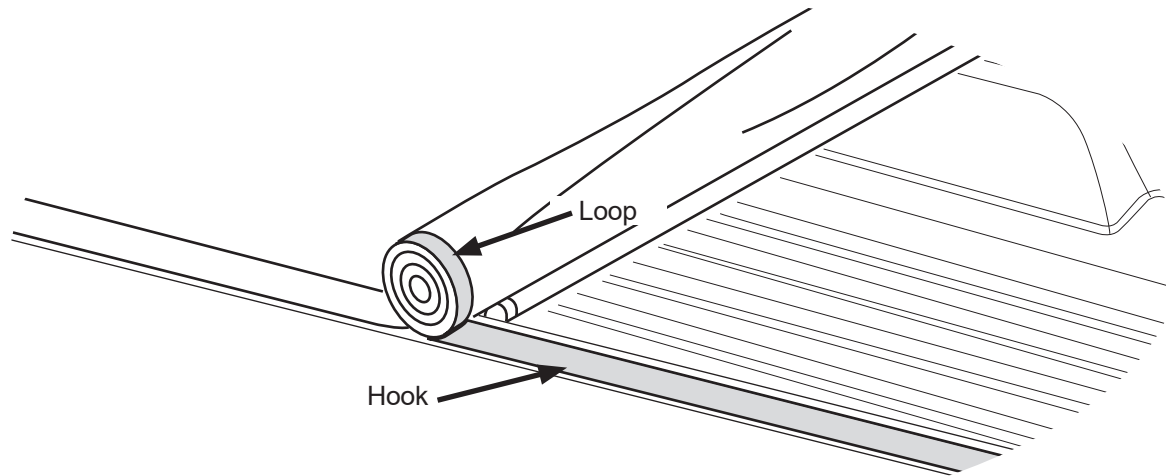
Pull the loop (on the fabric) tight from side to side to the hook (on the rail)

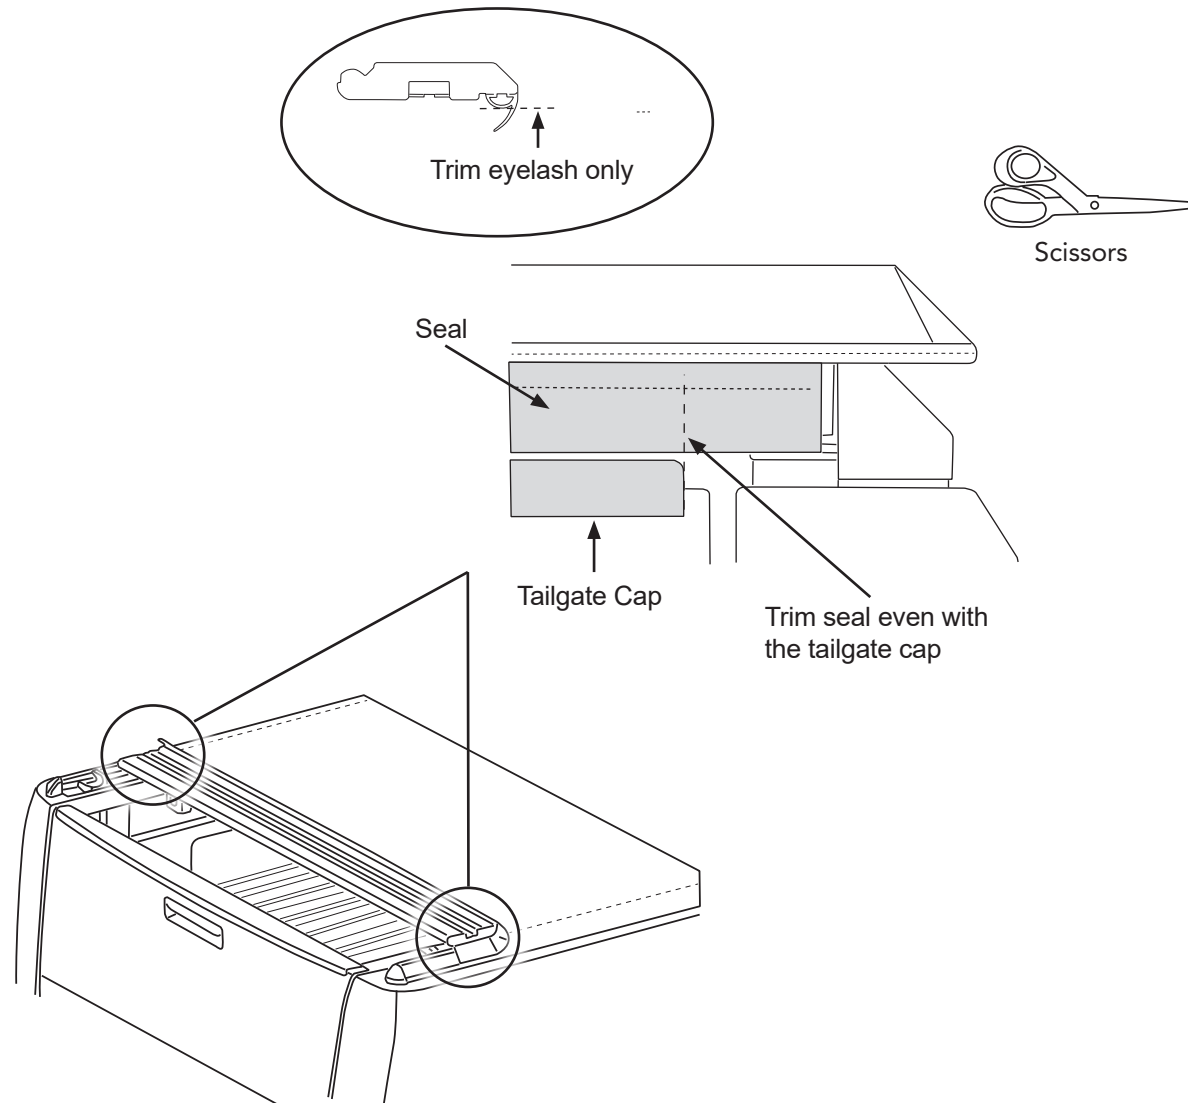
If your vehicle is equipped with a tailgate cap, you will need to trim the seal on the Tonneau Cover Assembly. Mark the seal at each end of the tailgate cap and use the scissors to trim the bottom part of the seal at the mark.

NOTE: Only trim the bottom part of the seal.
