#### **Vehicle Application:**

Dodge Ram

06-08 1500 & 06-09 2500/3500 W/TAILGATE SPOILER

Part Number: 19239

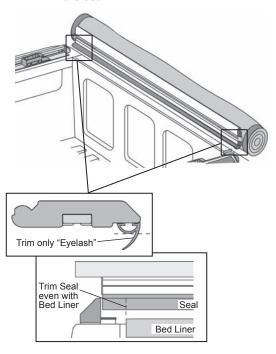
# Special Instructions – Bed Liners

If your vehicle is equipped with a Bed Liner that comes up over the front bulkhead, you will need to trim the seal on the Tonneau Cover Assembly. Mark the seal at each end of the of the Bed Liner and use scissors to trim the bottom, "eyelash", part of the seal at the mark.

Only trim the bottom, "eyelash", part of the seal.
