Vehicle Application:

- Fits RAM 5.5' bed
- 2009 2018
- Part Number: 19241

19241 pg. 2

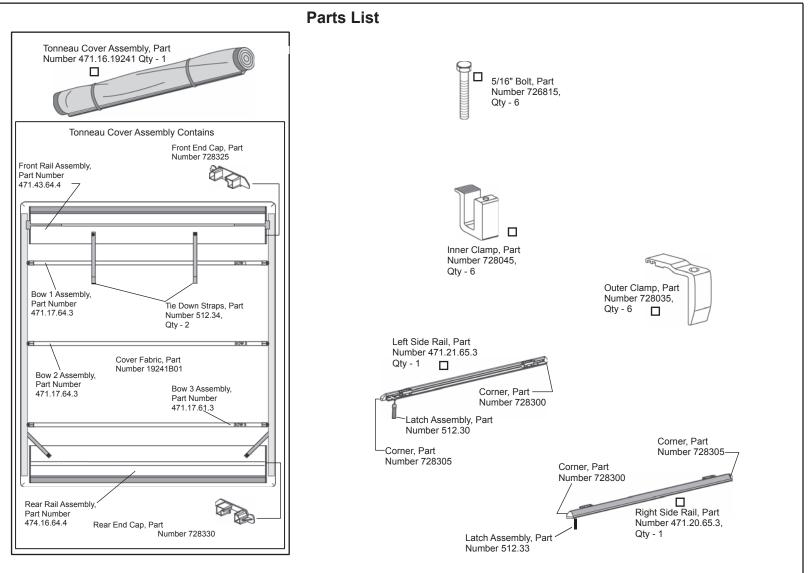
-5/16" Bolt

Assemble Clamps

Use a 5/16" Bolt to secure an outer clamp to an Inner Clamp. Repeat on all Clamp assemblies.
