Installation Instructions

Replace-a-Top

•Jeep Wrangler CJ7

Part Number: 51118

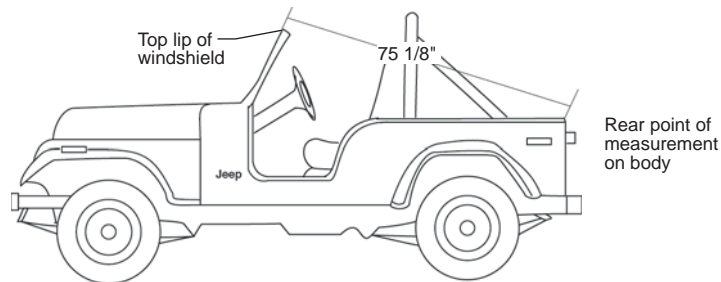
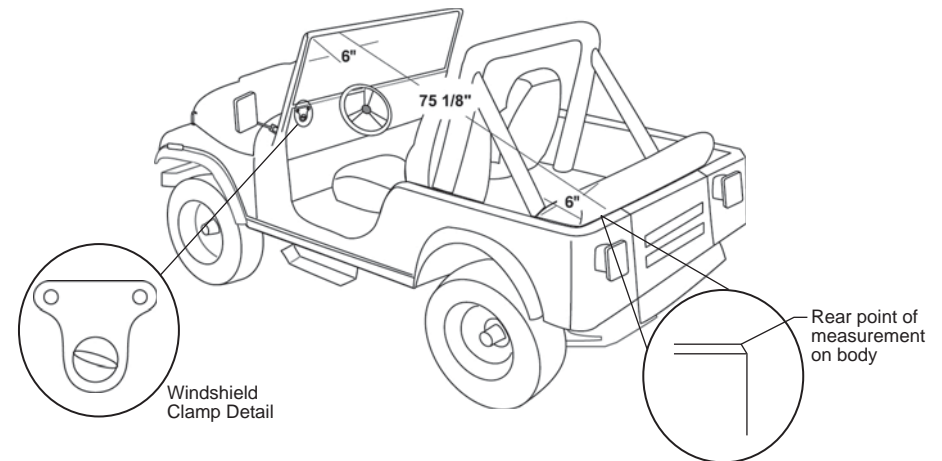
2 Windshield Adjustment

Measure and record the distance from the top lip of the windshield to the top outer edge of the vehicle body, but not the tailgate. Take the measurement from approximately six inches inside the vehicle's doors. Check to make sure that both sides measure equally. To install this top properly, this measurement must be 75 1/8".

If necessary, adjust your windshield by loosening the two screws in the Windshield Clamps located at the base of the windshield on each side of the vehicle. You may then lean the windshield forward or back as necessary. Use a shim to fix the windshield in place if it remains loose after you tighten the screws.

NOTE This is the first step you must take in the installation process and it is also the most important one. Improper windshield adjustment results in poor fitting of both the top and the doors, as well as misalignment of snaps.

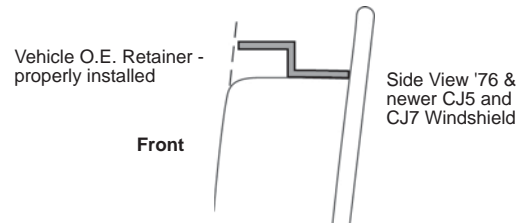
4 Check Windshield Retainer Placement

The original equipment windshield retainer on 1976 and newer CJ5 and CJ7 vehicles should be installed so that the front edge of the retainer is flush with the front edge of the windshield frame. If the retainer sticks out in front of the windshield frame, it will not leave a space large enough to hold the top securely at high speed.

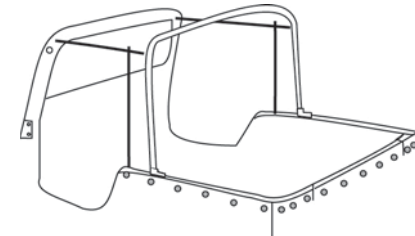
NOTE The snap placement on the top is the same as the original top. However, due to the installation variances, fabric stretch and manufacturing tolerances, it is possible that some of the snaps will not line up exactly. Therefore, we have included a few extra snaps and screws for the body in case you should find it necessary to move one or more snaps. These may also be used if you have broken snaps from your original top.

NOTE On 1976 - 1977 models the snap placement on the vehicle body was along the slanted edge of the body. In 1978 the tops were made longer so that the snaps are placed approximately 1 5/8" below the top edge of the body. This top is designed to replace the longer (1978 and later) top. If you have one of the short (1976 - 1977) tops on your vehicle, it will be necessary to install new snaps in the body as shown. To do this, start at the rear corners of the vehicle and stretch the top tight to insure a wrinkle free fit..

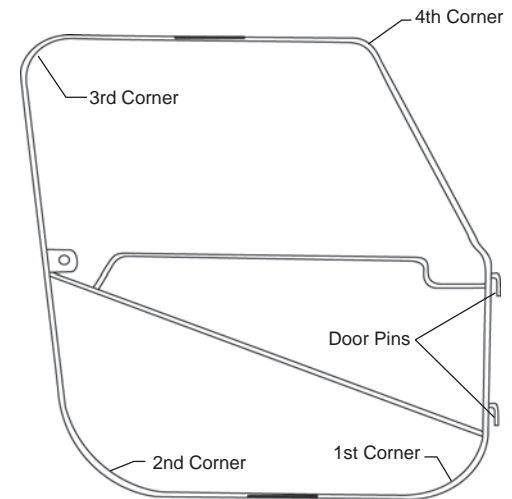
10 Install Door Covers

Start with the front of the door cover and locate the cut outs in the fabric for the door pins. Insert the door pins through the cut outs in the fabric and place the "First" corner into the pocket sewn into the fabric. Work around the door, slipping each corner into each corner of the elastic band. It may be necessary to unzip the upper window before sliding the elastic over the last corner.

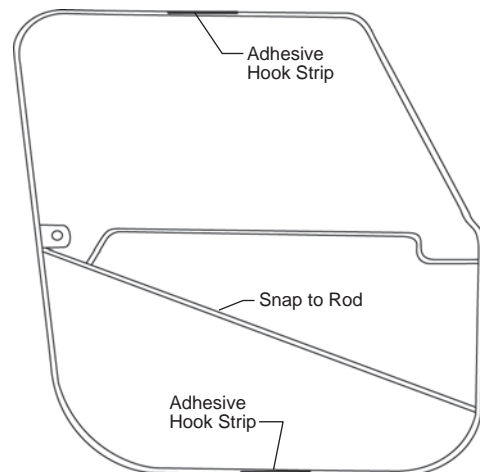
11 Secure Cover to Door Frame

After the fabric door covers are on the frames, install the adhesive hook on the door frame to match up with the loop strip sewn into the fabric cover. Snap the cover to the diagonal rod of the frame. Use a pair of scissors to cut a hole in each door for the handle and reinstall the handle. Make sure that you replace it the way it came off.

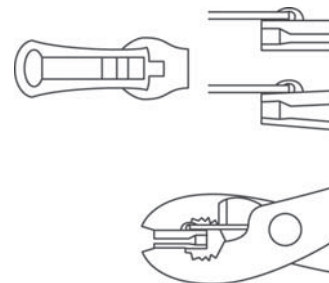
Normal Slider-
Jaws Parallel

Damaged Slider-
Jaws spread apart
(Sometimes broken)

Zippers: Keeping zippers cleaned and lubricated with Bestop's Zipper Cleaner (part no. 11206-00) will help prevent damage and keep the zippers in smooth working condition. If a zipper opens behind the slider, the slider may have been spread apart. This problem can usually be repaired by using an ordinary pair of pliers to bring the sides back into parallel. Return slider to the end of the zipper in the normal Open position. Squeeze lightly at first and test the zipper. If the zipper continues to remain open squeeze more firmly with the pliers and try the zipper again. Repeat this procedure until the zipper operates correctly.
