Installation Instructions

Fabric Replacement Top with Tinted Side and Rear Windows

- Jeep Wrangler Unlimited TJ
2004 – 2006
Part Number: 79140

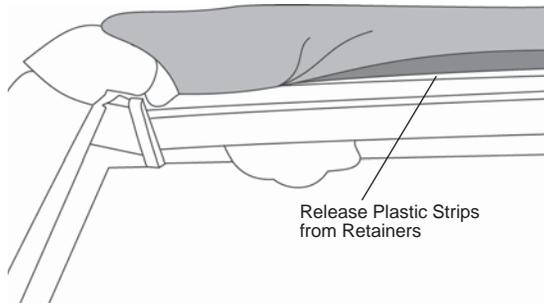
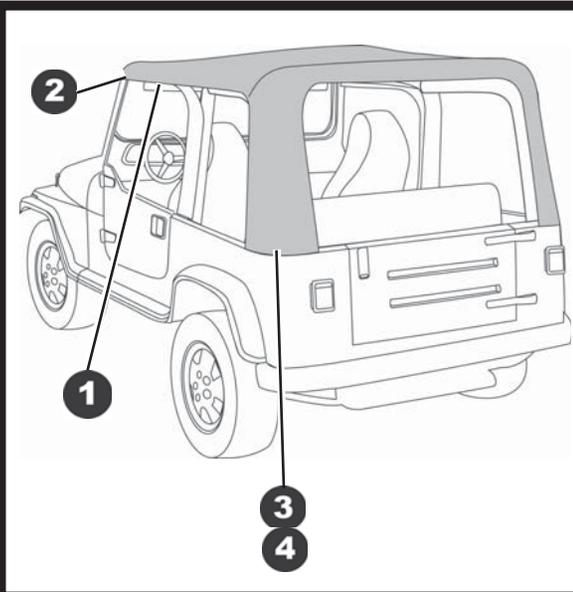
1 Remove Quarter Windows and Rear Window

Remove the Quarter Windows and the Rear Window. Remove the metal Tailgate Bar from the bottom of the Rear Window and set it aside. Release the plastic strip sewn to the top above the doors. Pull down and out to slip the plastic out of the channel.

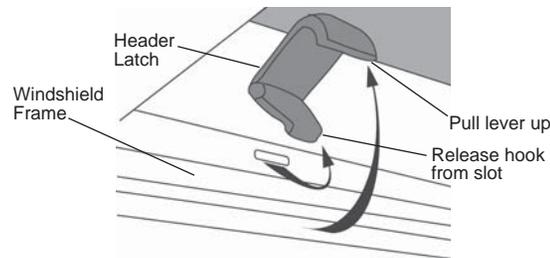
2 Release Windshield Latches

Release the latch that secures the header to the windshield. Pull up on the lever and then down and out to release the hook from the slot in the windshield frame.

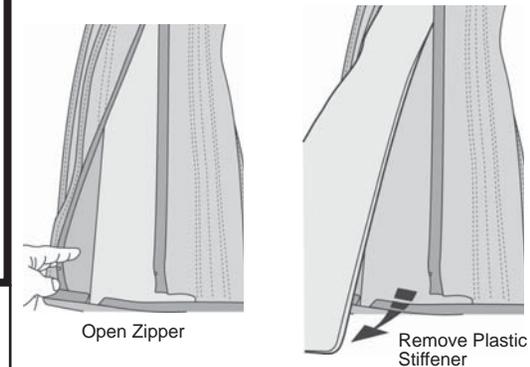
3 Remove Plastic Corner Stiffener

Locate the zipper inside the rear corner of the top. Open the zipper and remove the plastic stiffener in the pocket. Set the reinforcement aside to be reused later. Repeat this on both sides of the vehicle.

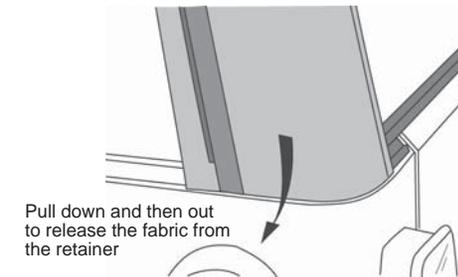
4 Release Rear Corners

Release the rear corners of the top. Pull gently down and then out to release the plastic strip from the retainer on the vehicle.

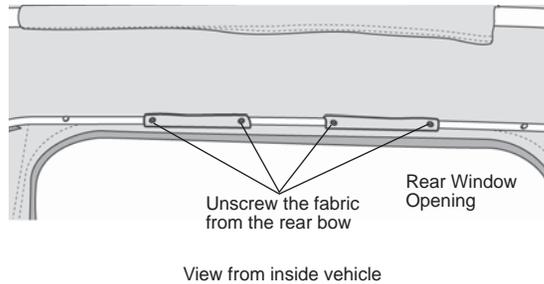
5 Release Rear Bow

Use a phillips screwdriver to remove the four screws that attach the flap in the top to the rear bow. Set the screws aside to be reused later. Allow the bow to drop onto the tailgate.

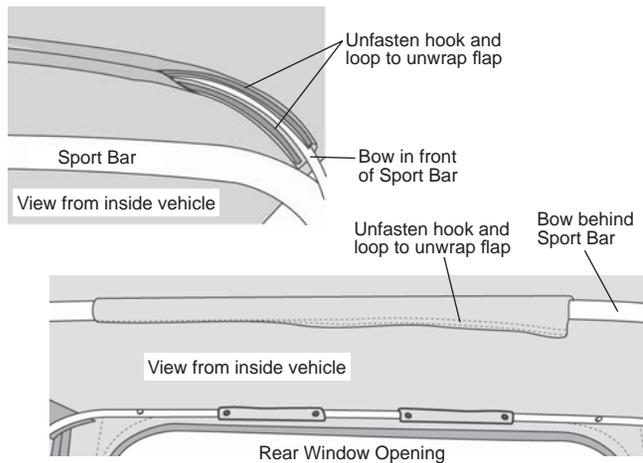
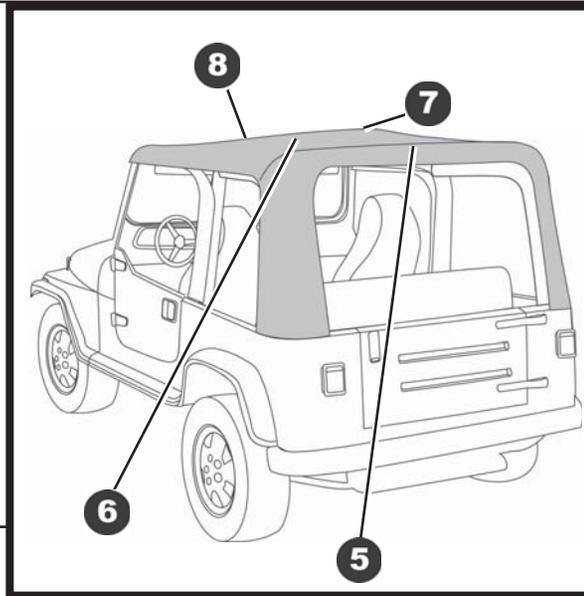
6 Unfasten Center Bows

Unfasten the hook and loop flaps around the Bows on each side of the sport bar.

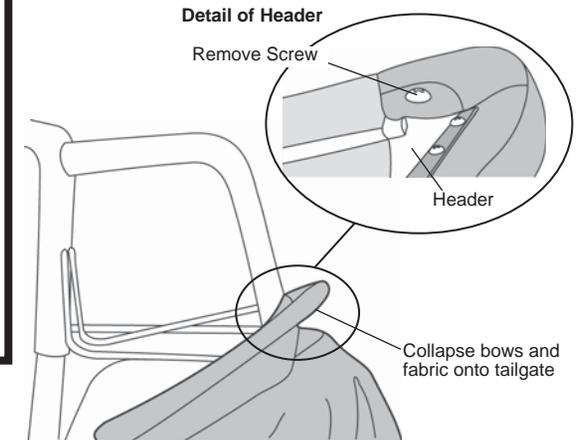
7 Remove Corner Screws

Collapse the bow assembly down onto the tailgate. With the bow assembly laying on the tailgate, remove the screws that fasten the fabric to the corners of the header. Set the screws aside for use in installing the new top fabric.

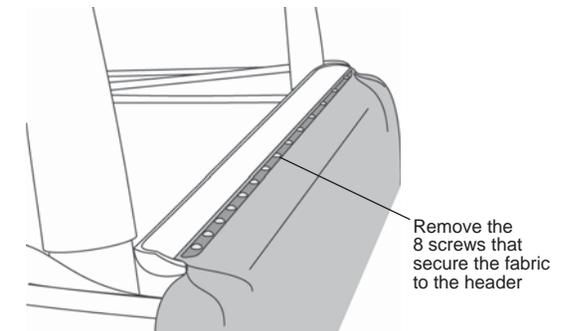
8 Remove Screws Holding Fabric to Header

Remove the eight screws that secure the fabric to the header. Set the screws aside for use in installing the new top. Then remove the old top fabric from the vehicle.

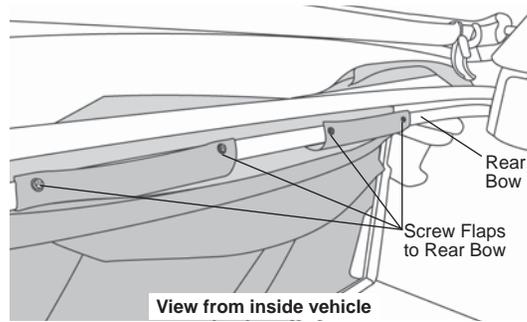
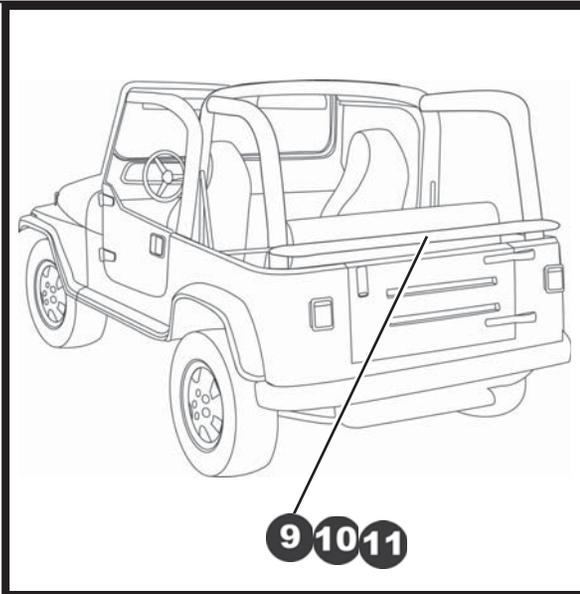
9 Attach Top to Rear Bow

Orient the Replacement Top fabric on the vehicle. Raise the header and bow slightly to allow you to attach the rear bow flaps, that are inside the top above the rear window opening, to the rear bow. Use the four (4) screws that were removed in Step 5 to secure the flaps to the bow.

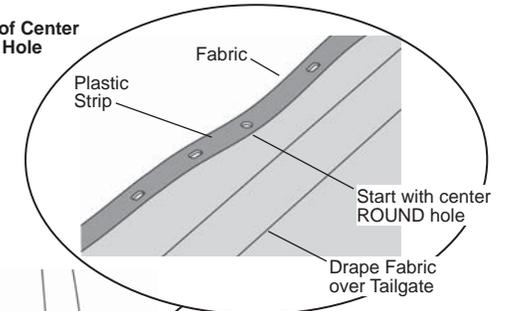
Detail of Center Screw Hole

Lay the top fabric with the plastic strip facing up and aligned with the front edge of the header. Locate the round hole that marks the center of the plastic strip (all other holes are slotted). Install a screw in the round hole to secure the fabric to the header as well as to center the top. Then proceed to install screws in the remaining seven holes along the front of the header.

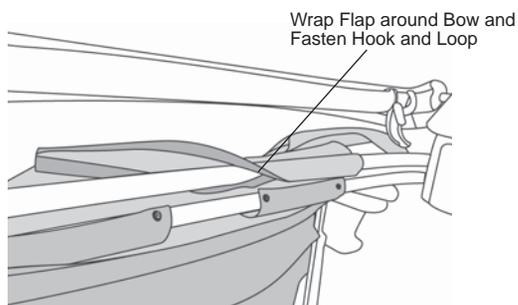
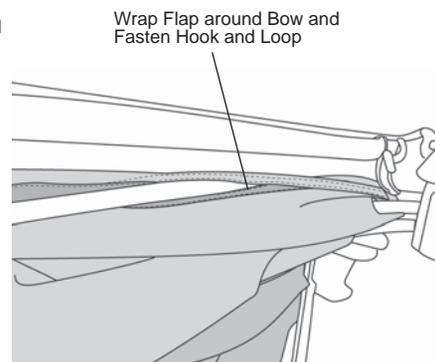
10 Secure Center Bows

Wrap the hook and loop flaps around the two Bows in the center of the top.

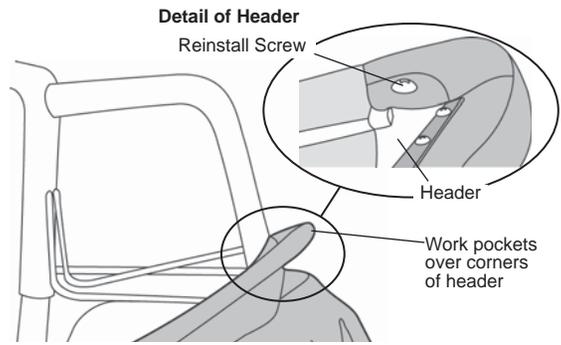
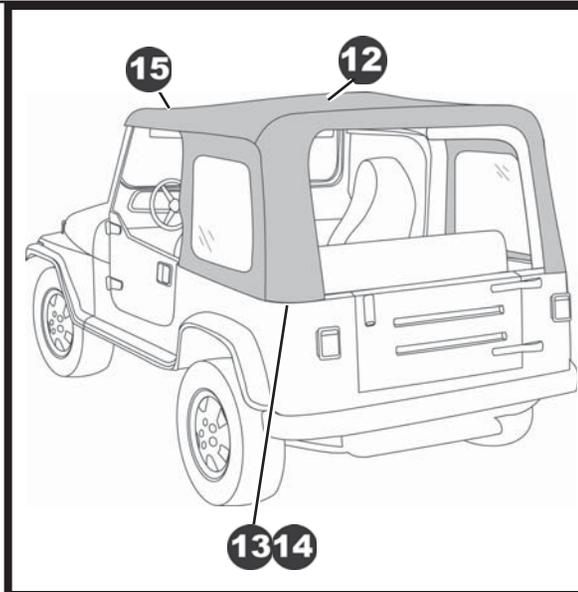
12 Install Corner Screws

Wrap the fabric around the header and raise the header slightly to work the pockets in the fabric over the corners of the header. Install one of the screws removed in Step 7 in each corner to secure the fabric to the header.

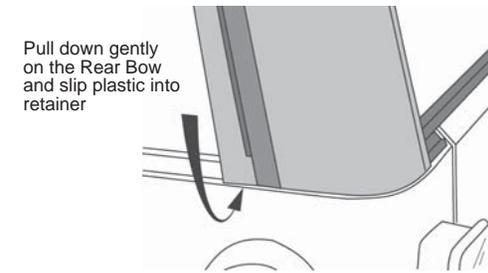
14 Secure Rear Corners

Pull down gently on the Rear Bow and work the plastic sewn to the rear corners of the top into the retainer on the vehicle.

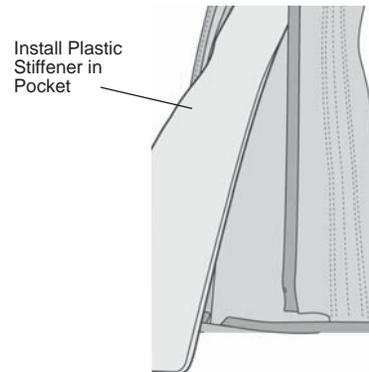
13 Install Plastic Corner Stiffeners

Open the zipper inside the rear corner of the top and install a plastic stiffener in the pocket. Repeat this on both sides of the vehicle.

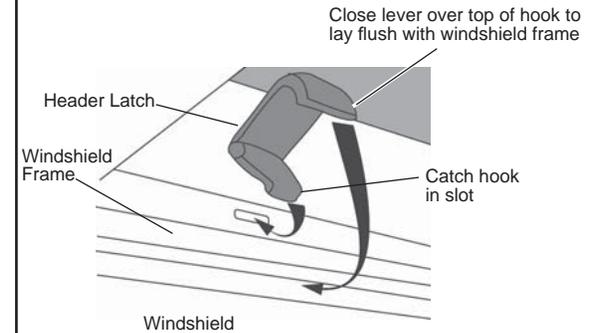
15 Secure Header to Windshield

Close the header latches to secure the front of the top to the windshield. Catch the hook in the slot in the windshield frame and then close the lever over it so that it lays flat against the windshield frame.

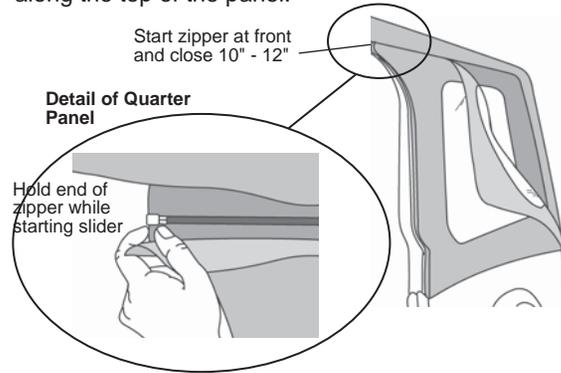
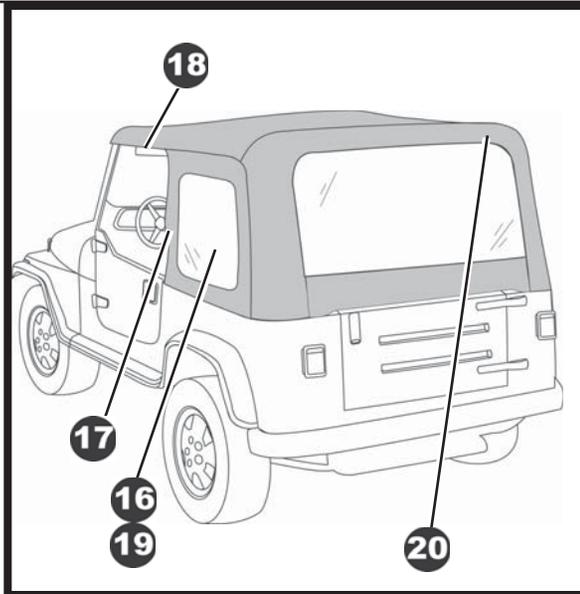
16 Attach Quarter Panel Zippers

Locate the left and right Quarter Panels and orient them with the zipper along the top and rear of the panel. Start the zipper at the front top corner of the Quarter Panel, next to the door. Hold the end of the zipper and close the zipper slider 10" - 12" along the top of the panel.

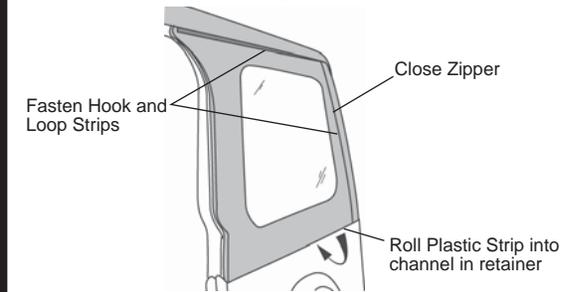
19 Secure Quarter Panels

Close the zippers on the Quarter Panels the rest of the way to the lower rear corner of the panel. Start at the rear and roll the plastic along the bottom of the panel into the retainer on the vehicle. Then fasten the hook and loop strips along the top and rear of the panel to the top.

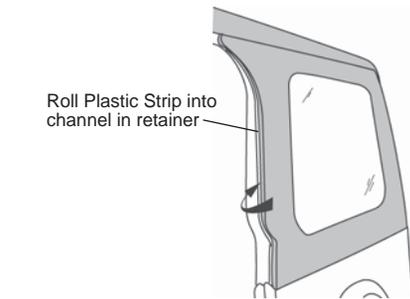
17 Secure Front of Quarter Panels

Roll the plastic along the front of the Quarter Panel into the channel of the Door Surround on the vehicle.

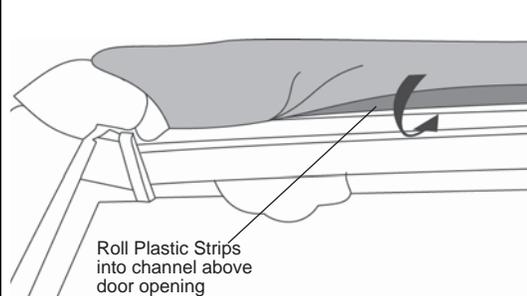
18 Secure Top above Door Openings

Locate the two plastic strips sewn to the sides of the top, above each door. Slip the strips into the channel in the Door Surround above the door opening. It is easiest to insert the front plastic strip into the channel first.

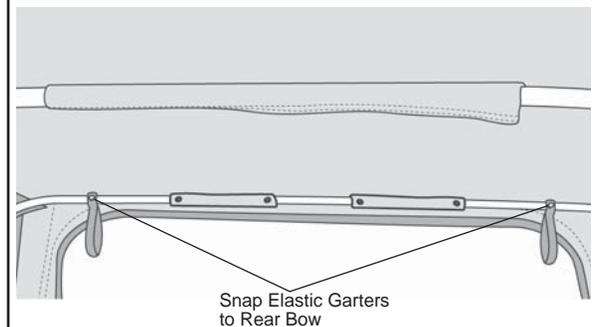
20 Install Elastic Garters

Snap the Elastic Garters to the snaps on the Rear Bow above the rear window opening.

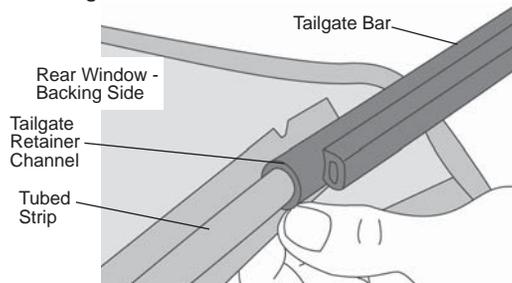
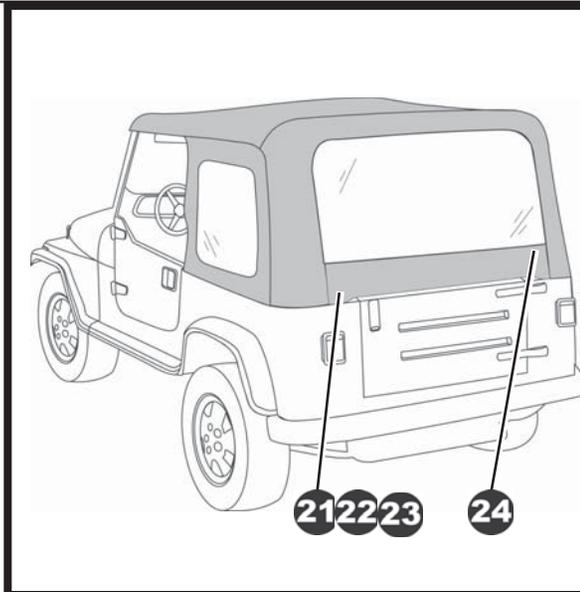
21 Install Tailgate Bar on Rear Window

Remove the Rear Window from the box and lay it flat with the backing side up. Locate the Tailgate Bar set aside in Step One. The bar has a “C” shaped channel, when viewed from the end. Orient the bar with the round seal down and slide the “C” channel on the retainer onto the tubed strip sewn to the backing side of the Rear Window.

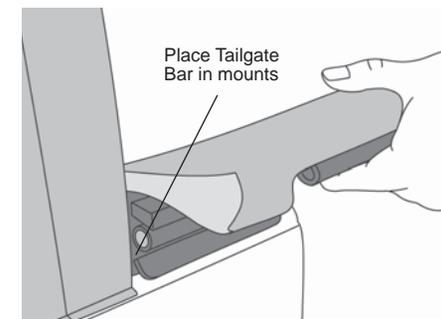
22 Install Tailgate Bar on Vehicle

Insert the Tailgate Bar into the mounts on each side of the tailgate opening with the vinyl side of the Rear Window toward the outside of the vehicle.

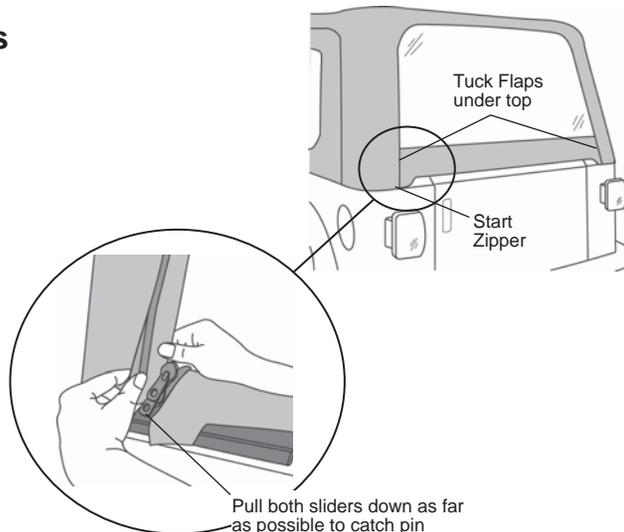
23 Secure Rear Window Zippers

To start the zipper, pull the two sliders as far down as possible on the driver's side of the window in order to catch the sliders to the pin. Once the zipper is caught, start the top slider 1/2". Then hold up the top of the window with one hand and close the zipper with the other. The zipper is sandwiched between layers of fabric in the corners so be careful not to catch extra fabric in the zipper. Close the zipper. Make sure that the Tailgate Bar is centered and is securely in the mounts. Then tuck the flaps on the Rear Window under the top fabric.

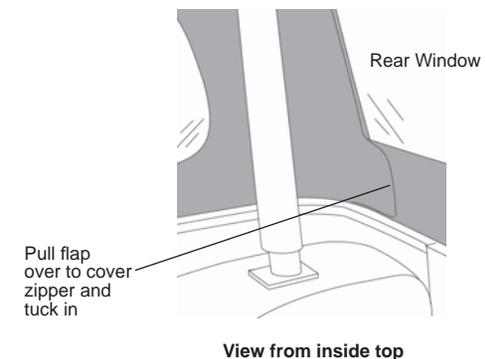
24 Secure Rear Window Flaps

Inside the top locate the flaps sewn to the top on each side of the rear window opening. Pull the flaps over to cover the zipper and tuck them in.

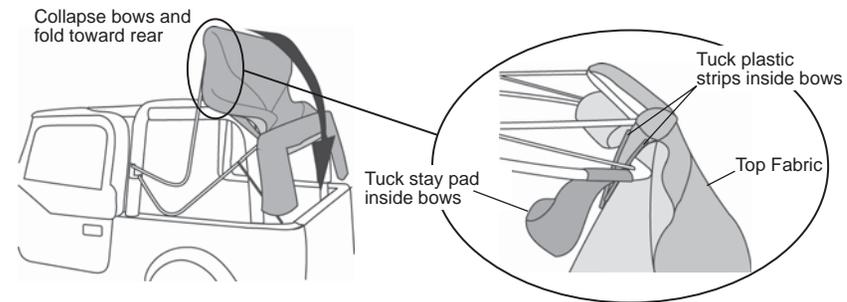
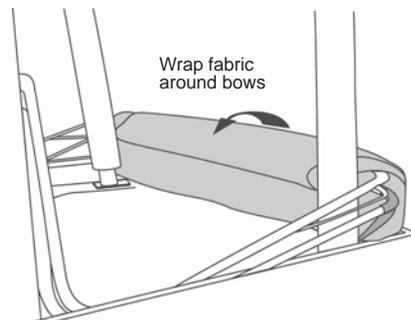
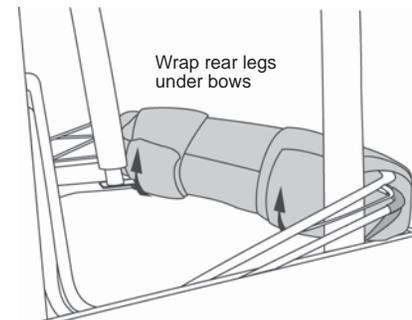
26 To Fold the Top Down Collapse Top

Remove the Quarter Panels and the Rear Window. To remove the Quarter Windows, unzip the rear and top zippers. Release the plastic strip from the retainer. Release the Hook and Loop Fasteners from around the Vertical Retainer.

To roll up the Rear Window, remove the Tailgate Bar and open the zippers on each side of the window to the top. Start at the bottom and roll the window to the inside. Avoid wrinkles in the fabric and window. Secure it in place with the elastic garters inside of the top.

Release the front of the top from the windshield. Raise the front of the deck and collapse the rear bows, tucking the two plastic strips above the door openings and the stay pad on the rear bow inside of the bows. Wrap the fabric around the bows, then tuck the rear legs of the top under the bows.
